# GLOSSARY OF COILED TUBING DAMAGE

Rev 20 7.17.24

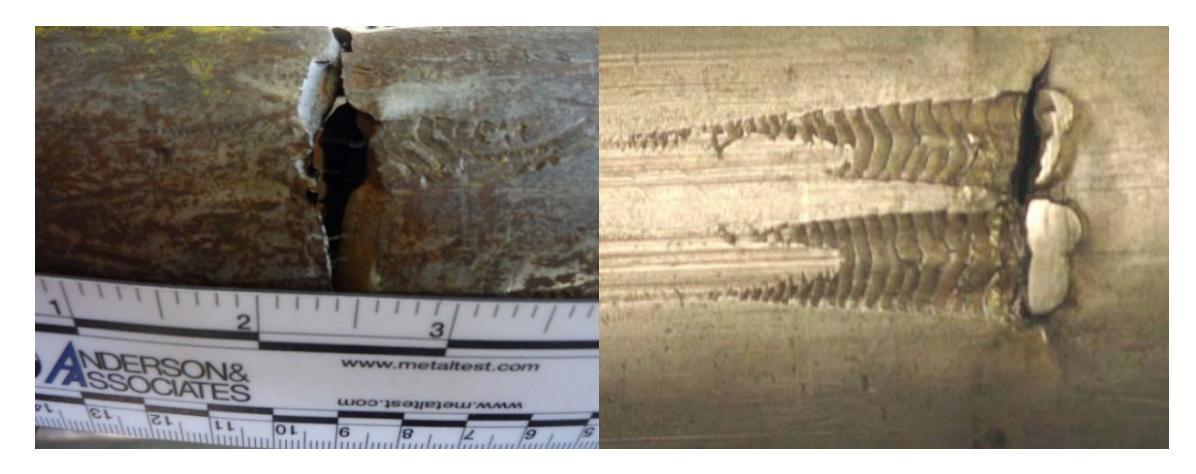
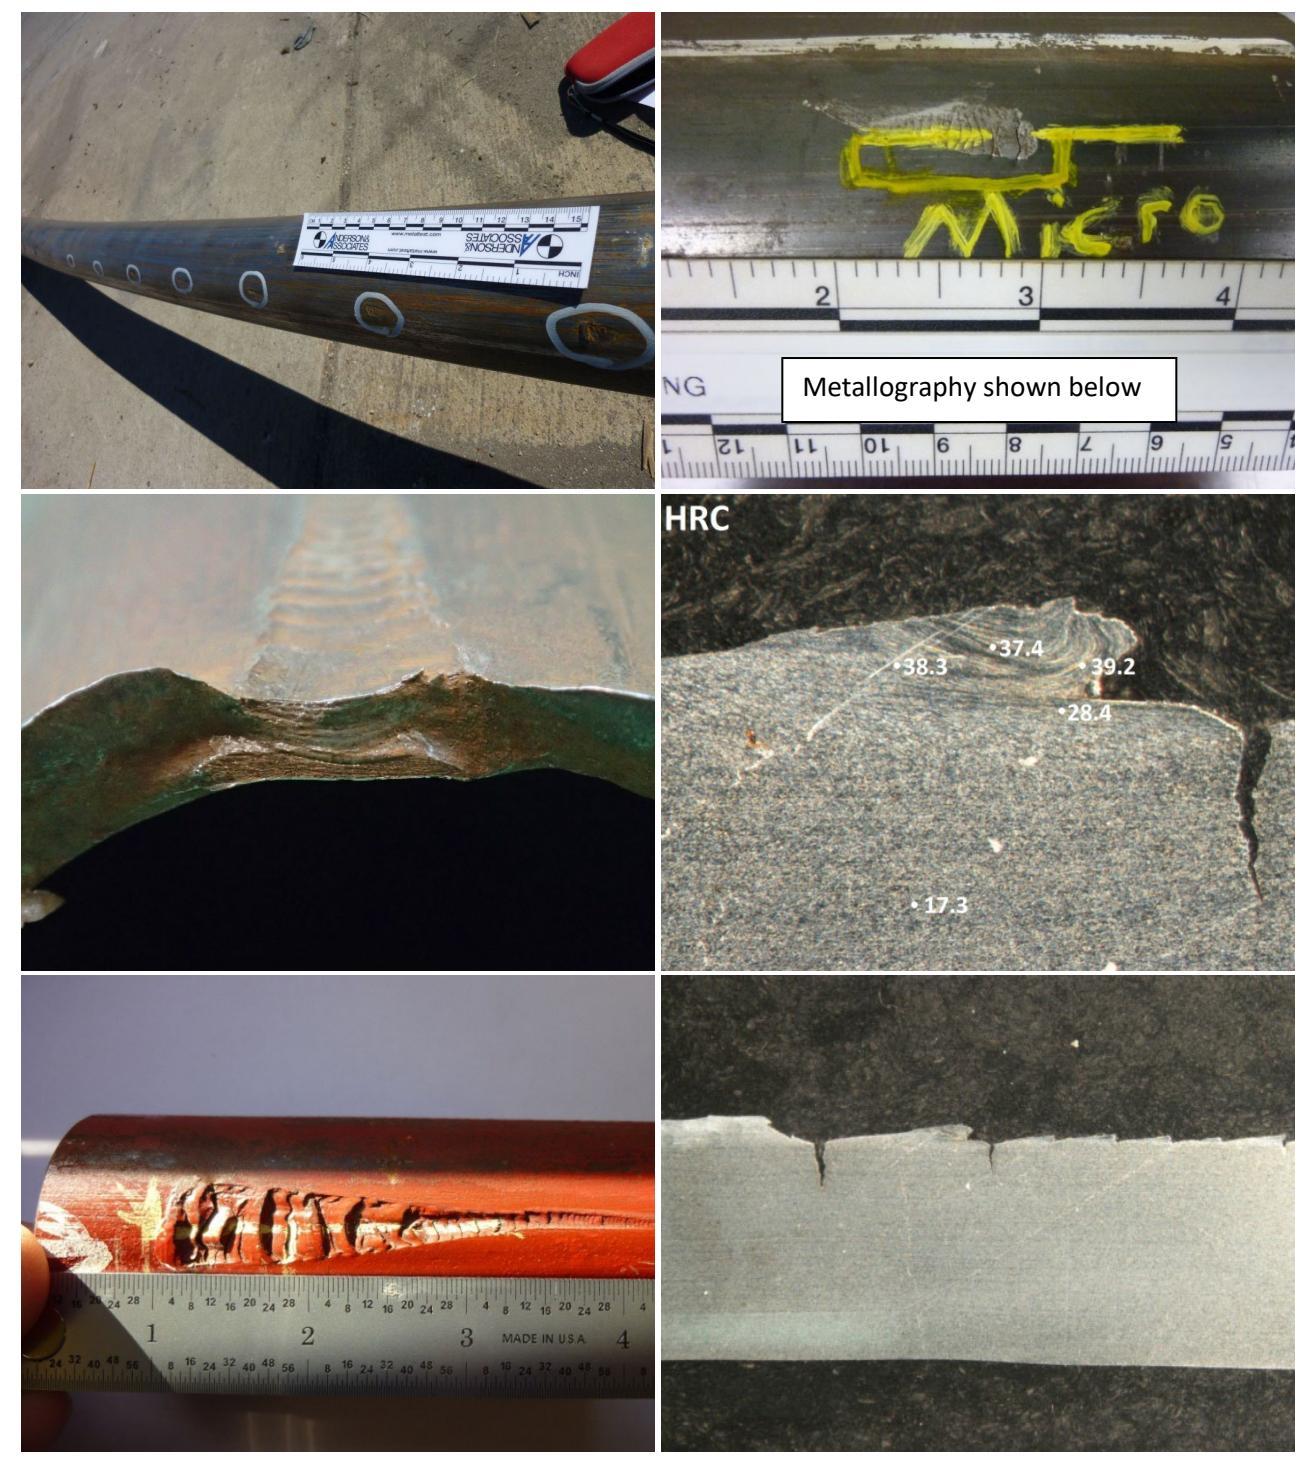
**DESCRIPTION:** Plow marks are a severe form of galling causing localized surface deformation. This produces a localized change in mechanical properties including an increase in hardness and reduced ductility. The damage reduces the wall thickness locally and the material is "plowed" to a termination point commonly associated with a mass of material generally flush with the surface.

**EFFECT ON FATIGUE LIFE:** Plow marks are extremely detrimental to fatigue life. If not repaired immediately after the damage occurs, subsequent bending cycles will propagate cracks at the root of each of the impressions as shown below. This propagation occurs readily due to the reduction in ductility and elevated hardness also shown below. Limited tests have indicated residual fatigue life to be 10-50% of the base tube depending on tube geometry and operating parameters.

**Plow Marks:** Note the increase in hardness and fractures emanating from the root of the mechanical damage. Immediate repair is critical to reduce the amount of cracking at the root of this damage followed by nondestructive examination such as Magnetic Particle or Liquid Penetrant Inspection to assure complete removal of the cracking.

**REPAIR:** Repair of plow mark damage is recommended immediately. Measurements from limited samples have found depth of plow mark damage to range from 10-30% of base wall thickness. Remove the damage per Global Tubing's "Managing and Repairing Field Defects" at the end of this document. Of specific importance with this damage is inspection using dye penetrant or magnetic particle testing after repair to assure all possible cracks are removed. Cycle tubing on and off the reel and re-inspect to assure all cracks are removed prior to use.

**MITIGATION:** Plow marks have several possible origins and each needs to be managed independently. INJECTOR HEAD – follow IH manufacturer guidelines for chain tension and skate pressure based on surface weight and snubbing forces. Tension and pressure will most likely need to be adjusted throughout the job to accommodate changing conditions. DOWNHOLE DEBRIS – maintaining good hole cleaning practices is essential. Monitor returns for expected cuttings at surface. Sufficient annular velocity and fluid rheology is necessary to carry all solids. Be sure to POH at a rate slower than the debris field (which is slower than the AV). To prevent buildup of debris in horizontal sections of the well, short trips back to vertical at scheduled intervals are suggested. WELL COMPLETION COMPONENTS – Thorough inspection of surface equipment and alignment prior to RIH.

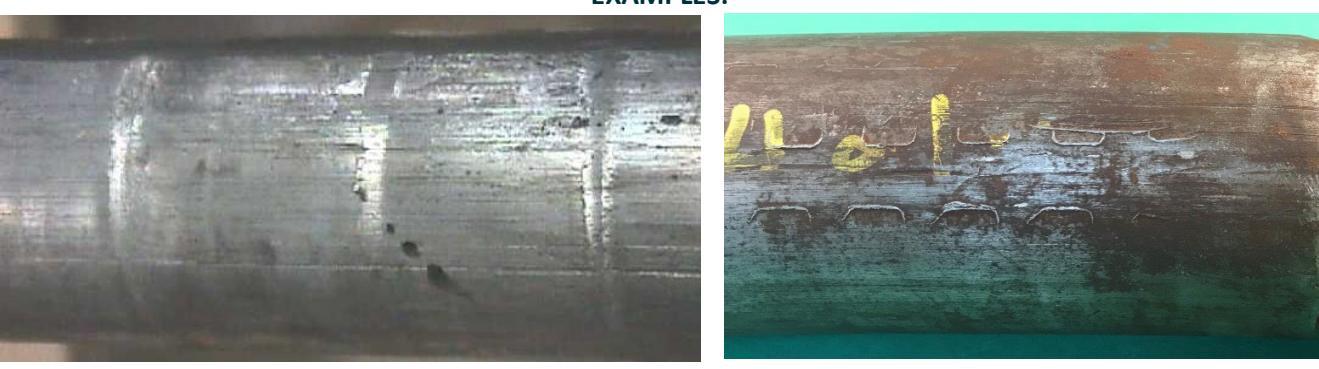
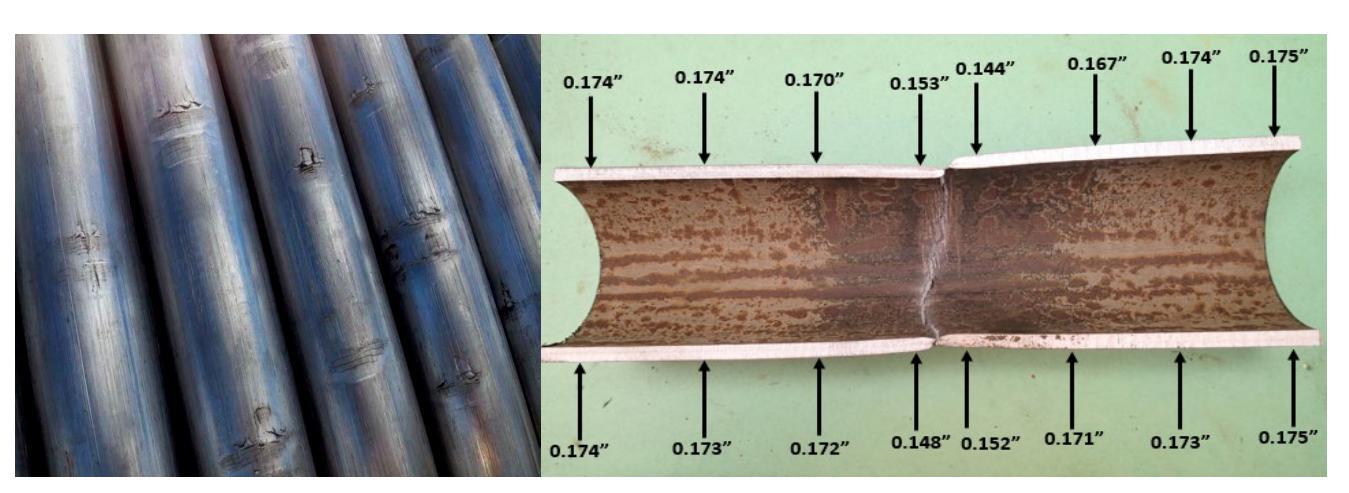
**DESCRIPTION:** Injector damage can be a combination of galling and abrasive wear. Normally, the orientation of this damage is in the transverse direction. The depth of the damage can be inconsistent depending on the tubing mechanical properties and injector parameters. Generally, damage of this type is shallow (<10% of base wall thickness) but can cause subsequent failure due to fatigue and subsequent wall reduction.

**EFFECT ON FATIGUE LIFE:** Transverse marks are detrimental to low cycle fatigue life. Normally, the shallow depth of such damage limits the reduction in fatigue life.

**REPAIR:** Repair of transverse injector damage is recommended when possible. Remove the damage per Global Tubing's "Managing and Repairing Field Defects" at the end of this document. However, many of these exceed 10% in depth or thin down with subsequent fatigue causing early failure.

**MITIGATION:** Follow injector head manufacturer's guidelines for chain tension based on snubbing forces seen during operations. As conditions change during operations, adjust chain tension accordingly.

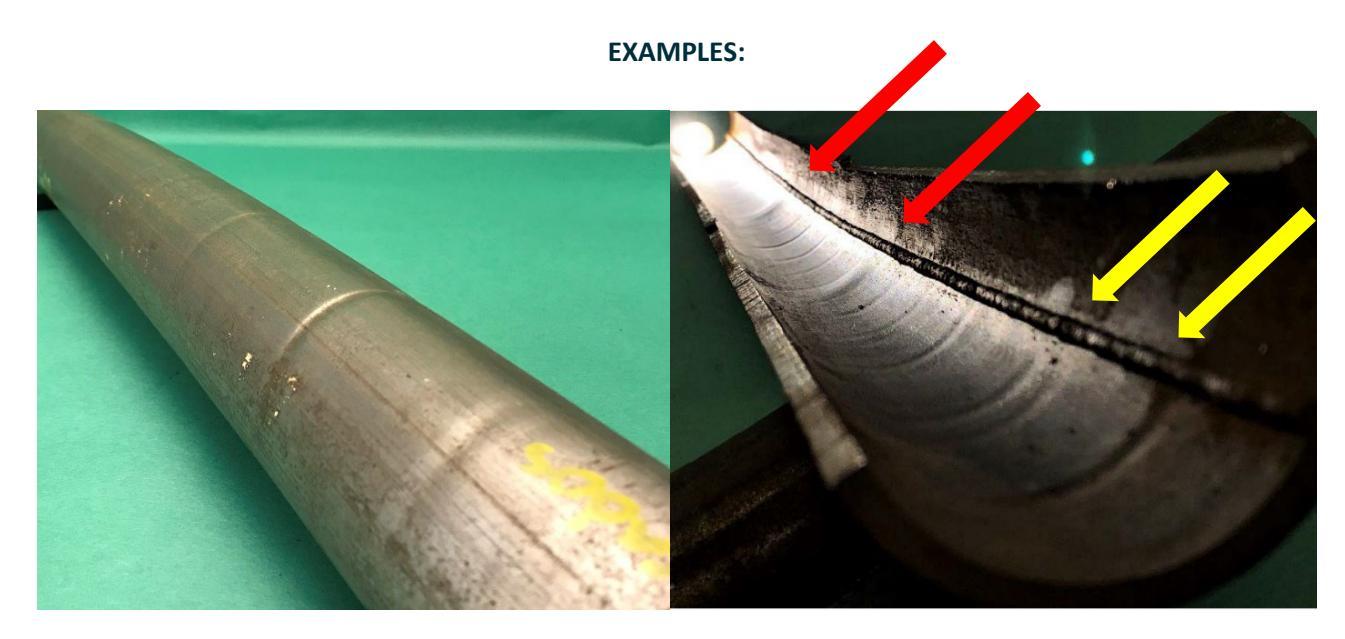
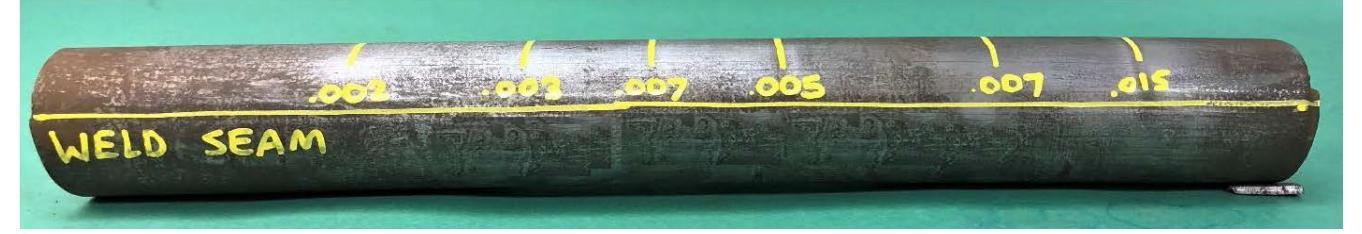
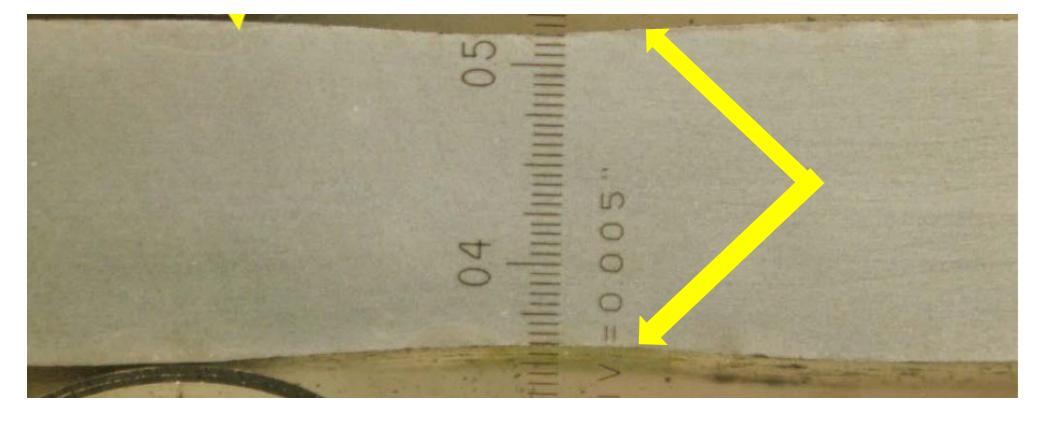
**DESCRIPTION:** Periodic OD indentations cause the ID to become smaller (red arrows) which causes a hinge effect and subsequent bending causes the wall thickness to neck down (yellow arrows).

**EFFECT ON FATIGUE LIFE:** Not repairable. Reduction in wall thickness and localized changes in hardness causes a reduction in tensile capacity.

**MITIGATION:** Frequent inspection of surface equipment and monitoring skate pressure and chain tension as well as alignment of gooseneck entry into the injector.

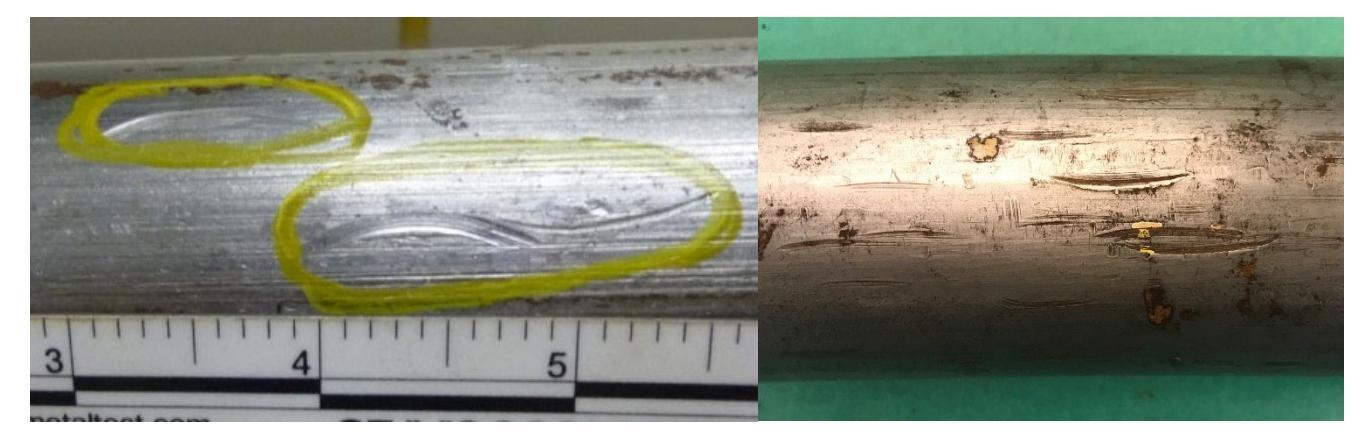
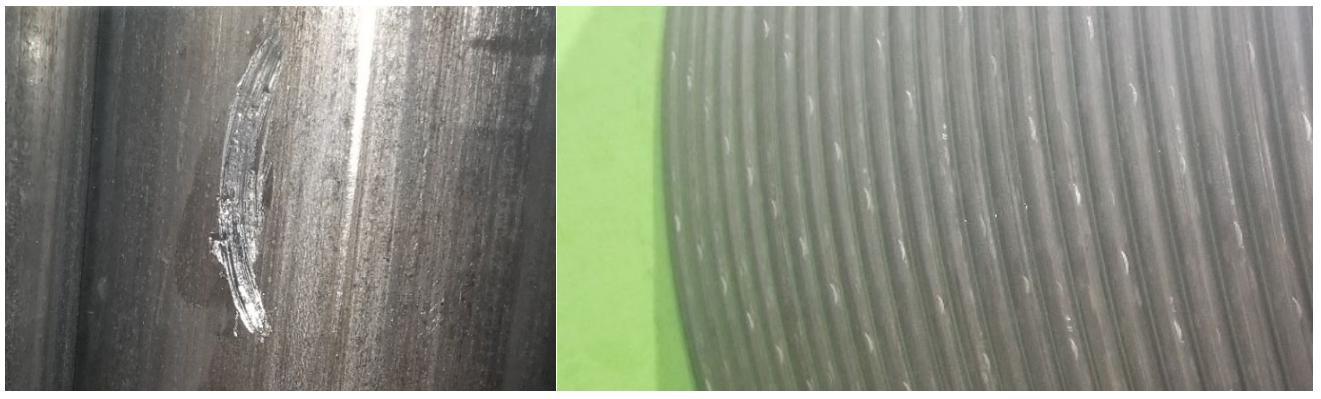
**DESCRIPTION:** Crescent moons are a form of abrasive/galling wear and are relatively smooth and uniform. This damage is imposed by the corner edge of coiled tubing injector head gripper blocks.

**EFFECT ON FATIGUE LIFE:** The orientation of this damage and the method of imposition result in minor reduction in low cycle fatigue life. Normally, the depth of this damage is less than 10% of the base wall thickness. More severe instances of this damage (10% or more of base wall thickness) may decrease fatigue life.

**REPAIR:** Repairing this damage type is recommended for the most severe cases. Remove the damage per Global Tubing's "Managing and Repairing Field Defects" at the end of this document.

**MITIGATION:** GOOSENECK ALIGNMENT – Ensure gooseneck is properly aligned in relation to the coiled tubing unit, as well as the injector head itself. GRIPPER BLOCKS – Monitor gripper block condition and securement to the chains on a regular basis. Follow injector head equipment manufacturer guidelines for chain lubrication and gripper block securement.

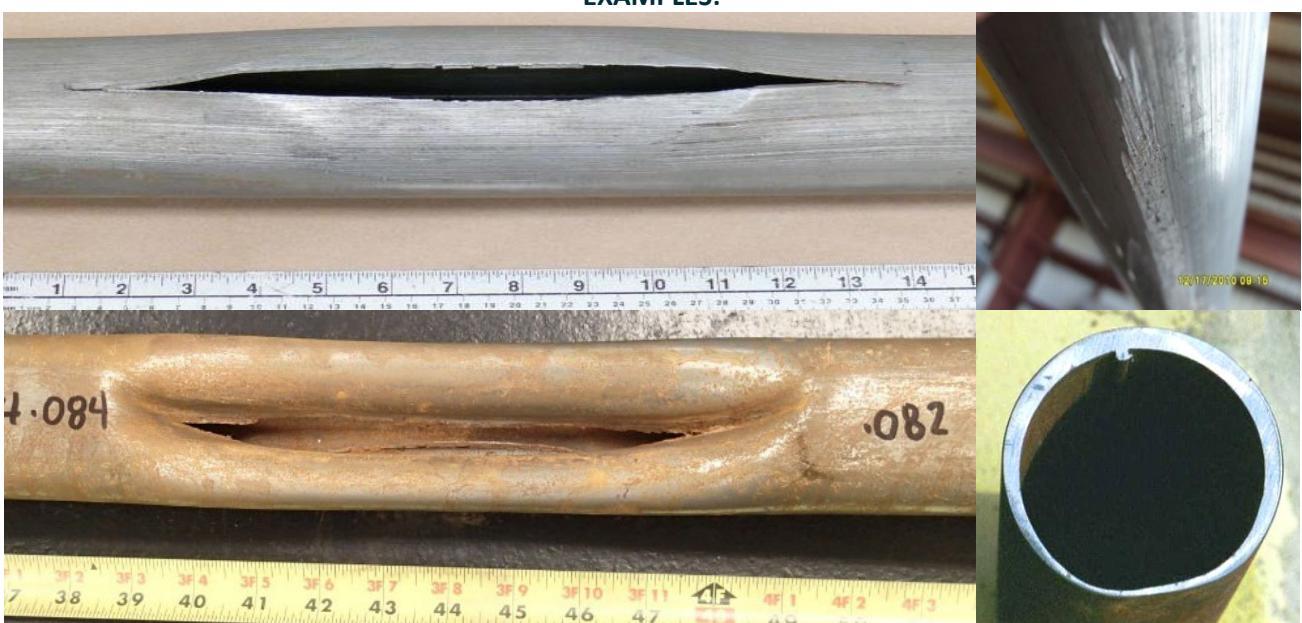
**DESCRIPTION:** Abrasion damage can be a combination of galling and abrasive wear. Normally, the orientation of this damage is in the longitudinal direction.

**EFFECT ON FATIGUE LIFE:** Because the orientation of most completion damage is in the longitudinal direction due to sliding wear of the pipe against the casing, the detrimental effect on fatigue life due to the damage itself is minimal if the wall loss is minimal. The primary failure mode is burst or collapse as shown in the images below.

**REPAIR:** Repairing longitudinal abrasion damage and scratches will have a minimal improvement in fatigue life. If wall thicknesses are within specification, it is better to not repair. If wall thicknesses are measured to be below specification, then it is recommended the section be removed completely.

**MITIGATION**: Constant pipe movement is essential especially when in the horizontal section of the well. Watch for abrasion, especially near the coil connector. Trim pipe on a regular basis regardless of any indication of abrasion. Use of friction reducers can also reduce the propensity to this type of damage. Watch for spooling damage such as shown in the "Wave" section of this report which can cause localized abrasion. Attempt to crop strings near the BHA in the straightest area to attach BHA's. See subsequent section on **BHA connector failures.** This minimizes localized contact normal forces and reduces propensity to abrasion. Short trips may reset the helix when spending a lot of time on one plug and focus the abrasion in a different location.

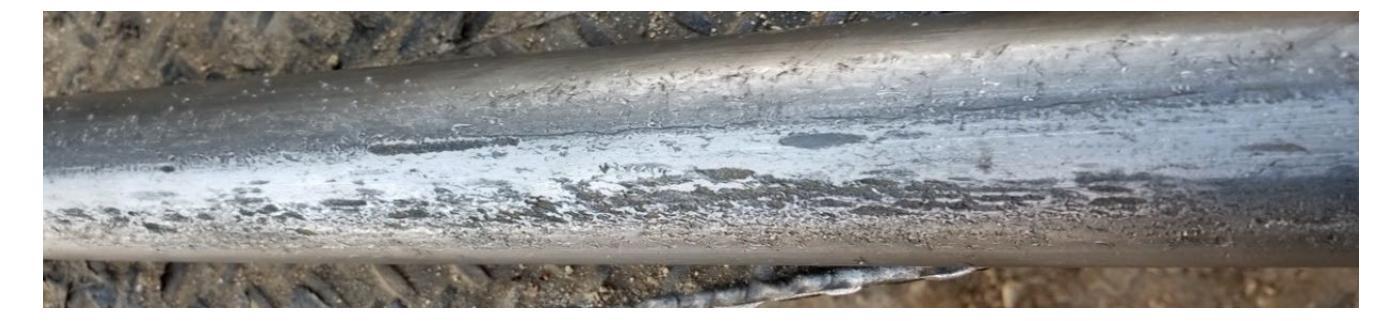
**POSSIBLE SOURCE:** Abrasion from contact with casing and/or coupling.

**EFFECT ON FATIGUE LIFE:** Damage in the axial direction may have minimal impact on fatigue, however excessive wall loss will reduce pressure capacity and fatigue.

**MITIGATION:** Use of friction reducers and monitoring highly deviated well profiles for areas most susceptive to high normal forces.

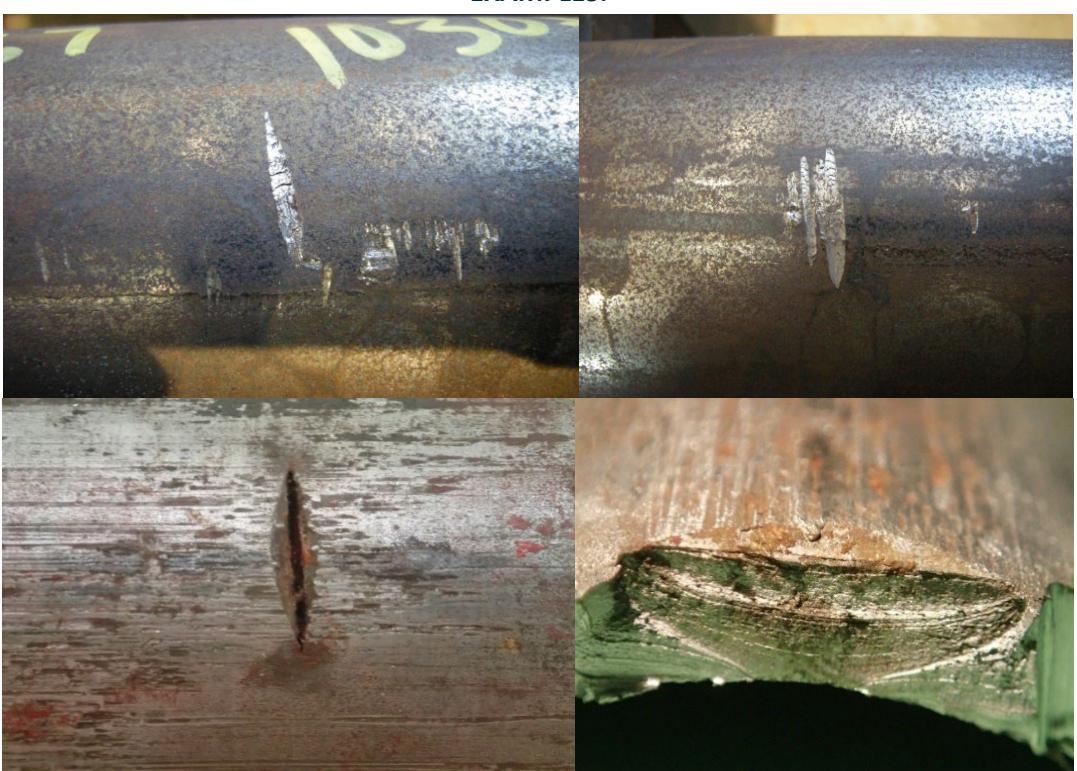
**DESCRIPTION:** Spooling damage is normally transverse galling. The orientation of this damage on the tubing is generally either the outer surface of the tube, or 90 degrees from the outermost surface of the tubing while on the spool. The depth of spooling damage ranges from 0-20% of base wall thickness. High grade (90+ksi yield strength) and large OD (2" +) have a greater propensity for spooling damage due to increased contact forces involved during spooling.

**EFFECT ON FATIGUE LIFE:** The orientation of this damage on the tube effects fatigue life. Because the damage is transverse, the reduction in low cycle fatigue life is moderate. Quantifying the reduction in fatigue life is difficult due to the varying depth and length of damage.

**REPAIR:** Repairing spooling damage is recommended. Remove the damage per Global Tubing's "Managing and Repairing Field Defects" at the end of this document. Check for cracking after repair by MPI or LPI after spooling to assure the entire crack is removed.

**MITIGATION:** Use good spooling practices. Wraps should be tight, and even throughout the reel. Avoid crossing over previous wraps and any gaps in the corners of the reel. Lubricate pipe on reel while spooling.

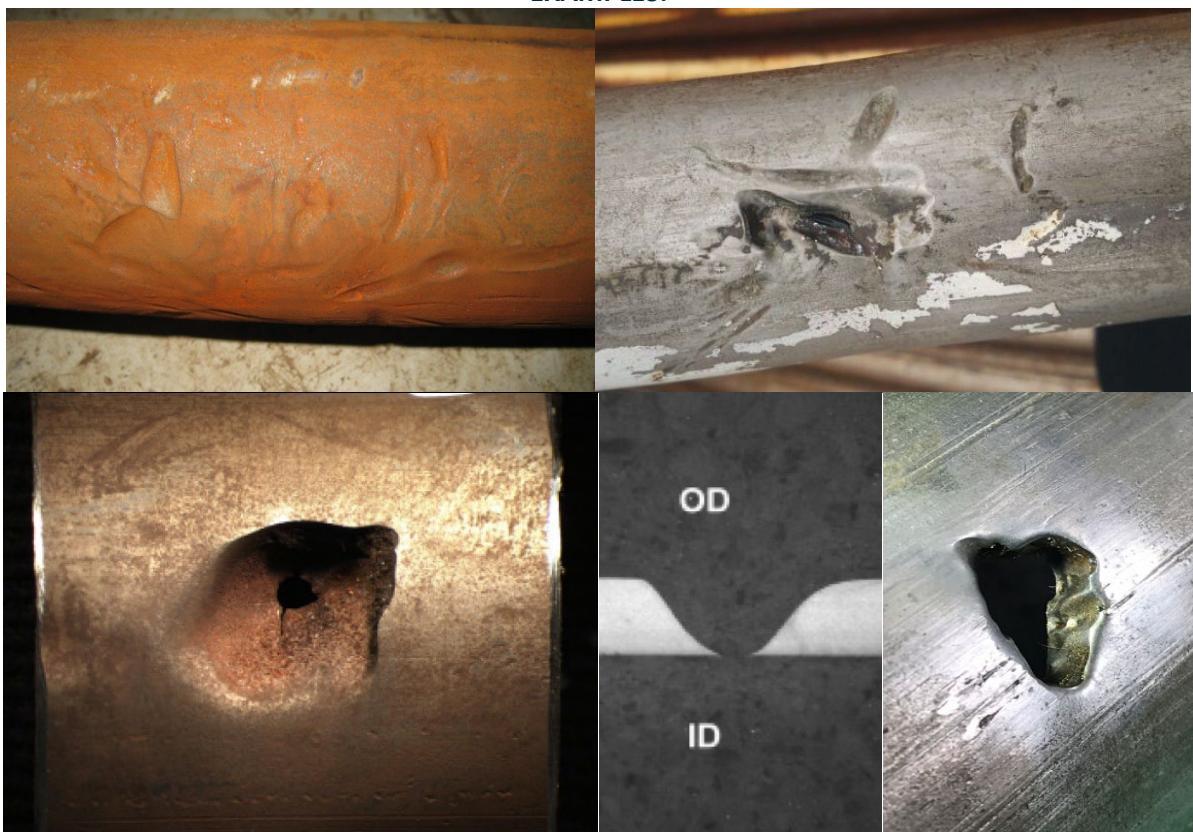
**DESCRIPTION:** Washout damage is a type of erosive wear. Washouts are typically very smooth and non-uniform in shape and depth. They are also independent of tube grade and hardness.

**EFFECT ON FATIGUE LIFE:** Washout damage reduces fatigue life by reducing the tubing wall thickness. The smooth nature of washout damage is less detrimental than damage of the same depth with jagged, point contacts, but because the shape and depth of washouts are impossible to predict, the reduction of fatigue life is also difficult to predict. Most likely, the reduction in fatigue life is large due to the aggressive nature of erosion.

**REPAIR:** Normally, this sort of damage is considered irreparable. If chosen to remove the damage, use Global Tubing's "Managing and Repairing Field Defects" at the end of this document, or remove completely and perform a tube-to-tube butt weld.

**MITIGATION:** Keep pipe moving at all times during the operation, especially when cleaning/returning a high volume of abrasive debris or taking returns at a high velocity. Using a flow cross instead of a flow tee at the well head which allows for multiple fluid flow paths and reduces the chances of flow path impingement.

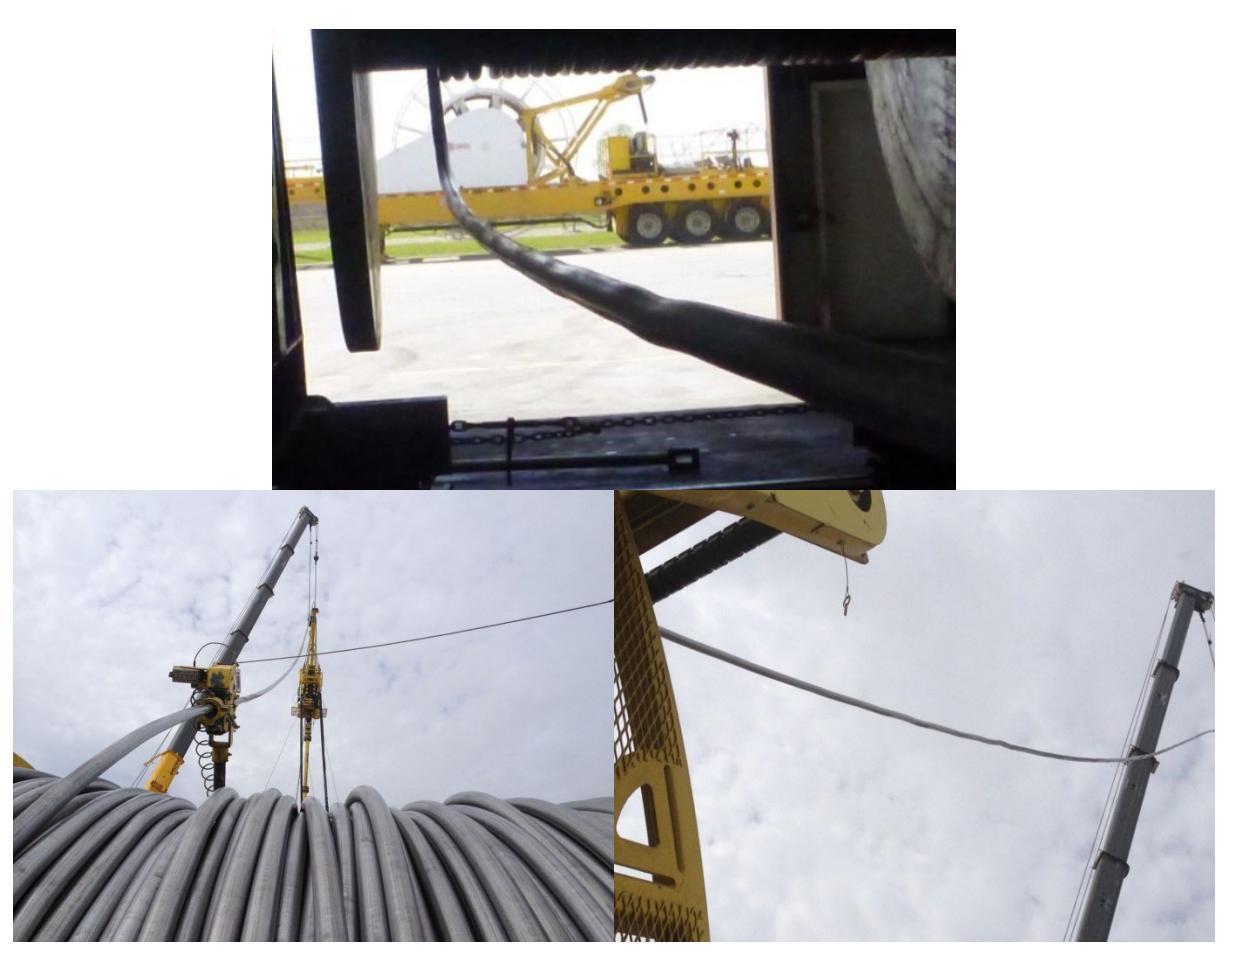
**EFFECT ON FATIGUE LIFE:** Wave deformation is not considered detrimental to long term performance of the tube and generally goes away after a few trips. Abrupt changes can however cause localized abrasion if the localized areas remain after several trips.

**REPAIR:** Subsequent plastic deformation (normal spooling) will reduce the appearance of this type of anomaly. Inducing a reverse bend will expedite removal of the wavy appearance.

**MITIGATION:** Use good spooling practices; wraps should be tight and even throughout the reel. Avoid crossing over previous wraps and any gaps in the corners of the reel. Coiling similar to lower left photo should be avoided. Lubricate pipe on reel while spooling.

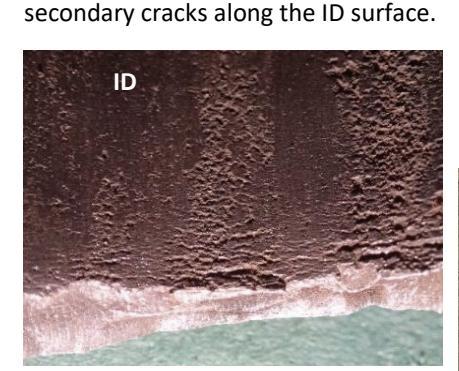
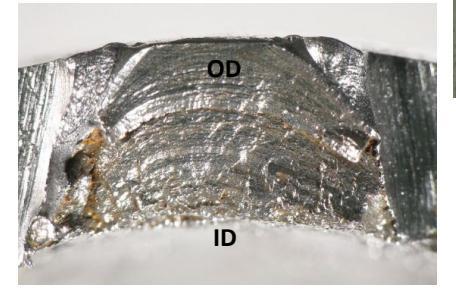
Examples of deep corrosion pits and

Fracture surface of the pinhole showed coarse fatigue striations emanating from the roots of the pits along the ID.

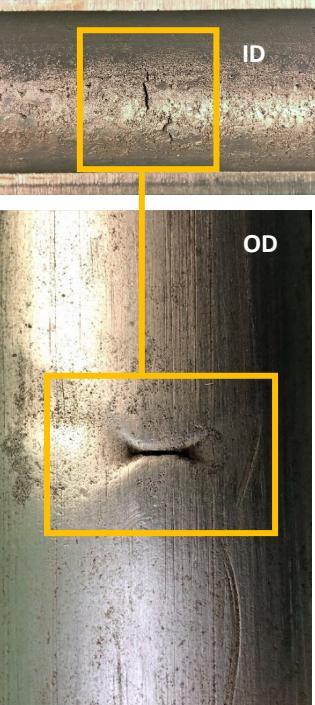
Example of a metallurgical mount of ID corrosion pitting and cracks as deep as 0.095" with ductile necking on the OD surface.

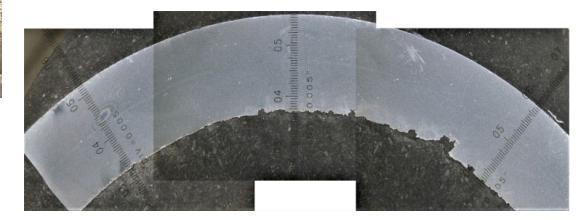
Prior catastrophic failure (complete fracture), a locally necked crack (pinhole) will be developed on the surface OD of the tube. This crack originates from roots of a severe pit along the ID. The orientation is transverse to axis of tubing and exhibits a characteristic "Y" at terminal ends of the crack.

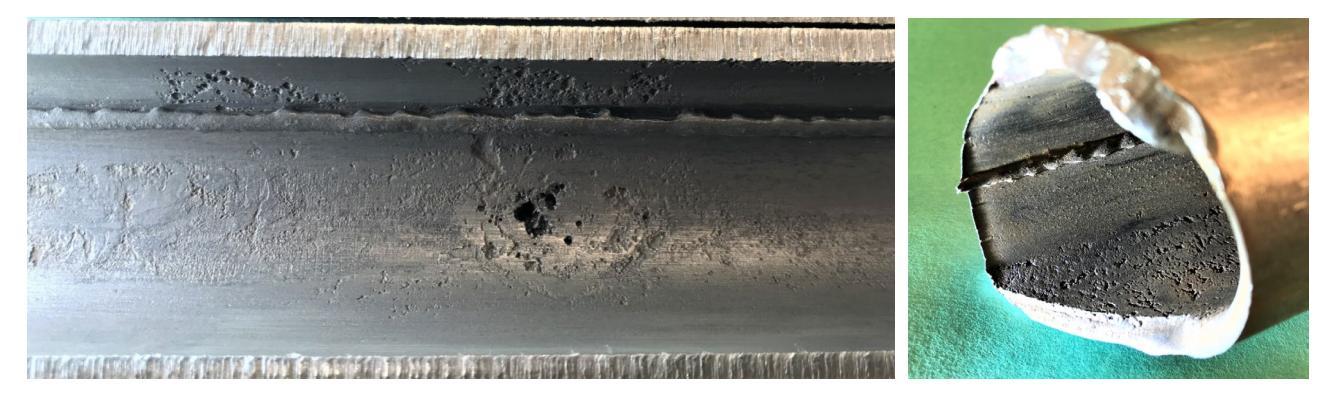
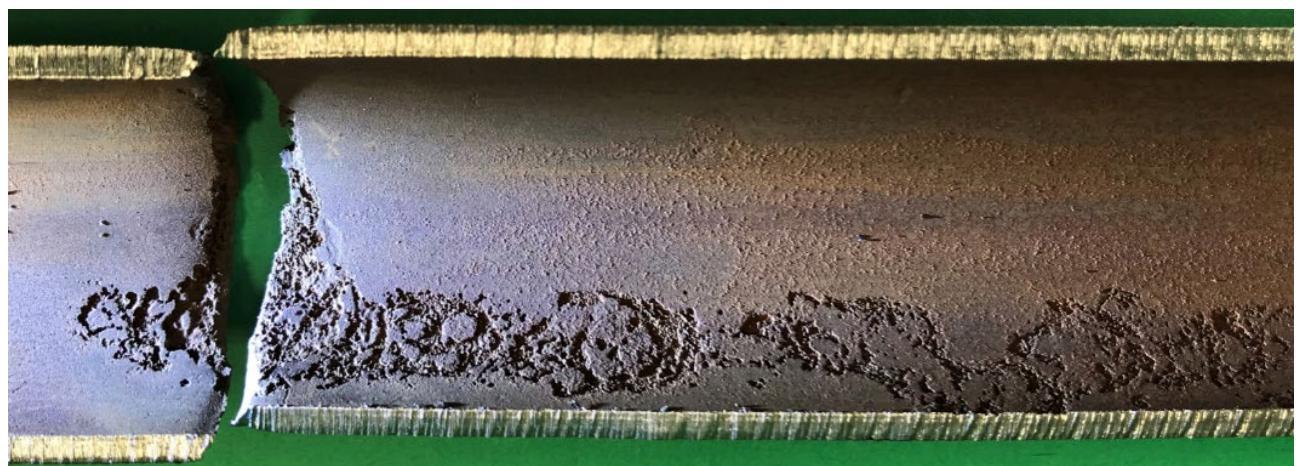
**DESCRIPTION:** In between jobs, 2-3bbl of fluids are typically left in CT strings even after N2 purge, especially when pigs/wiper balls are not used during the purge. This fluid allows for the development and build-up of a biofilm that creates scale and corrosion pits.

EFFECT ON FATIGUE LIFE: Not repairable.

**MITIGATION:** Frequent pigging of the coil will reduce scale buildup and limit ponding corrosion by breaking up biofilm and allowing chemical treatments to penetrate to the surface of the tubing rather than the rust film.

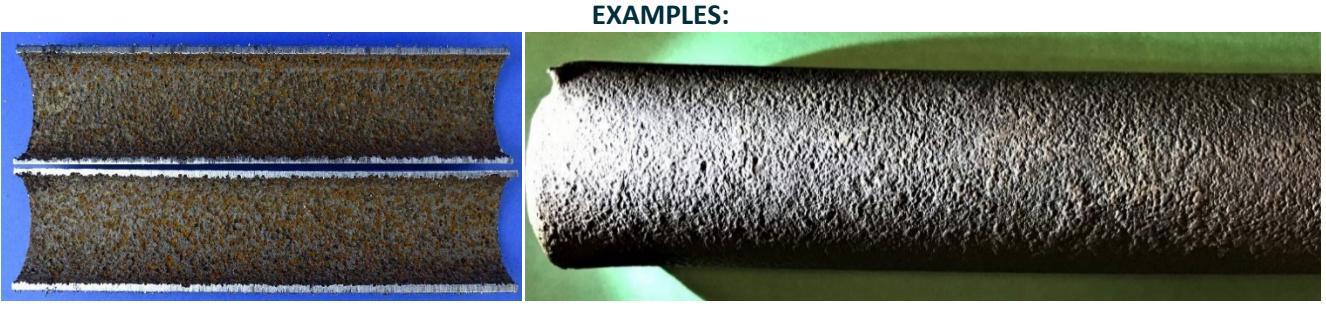
ID surface showed severe cavernous pitting.

OD surface showed severe cavernous pitting.

**MITIGATION:** Proper chemical treatment and fluid management ensuring adequate neutralization and use of soda ash between jobs to assure ID weld bead remains intact, and OD surface does not suffer further corrosion attack.

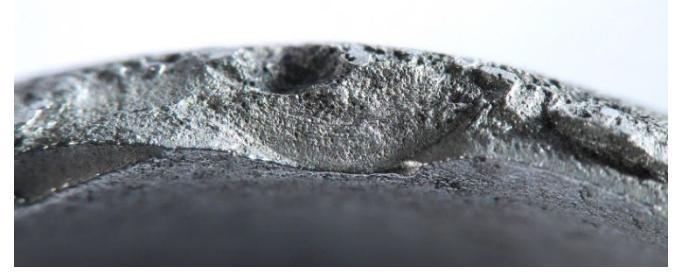
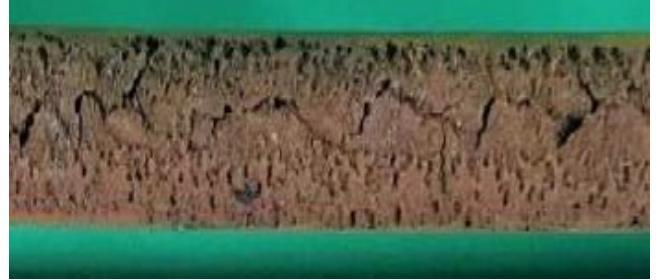
Corrosion pitting observed on the OD surface with fatigue fracture emanating from the root of the corrosion pit toward the ID surface.

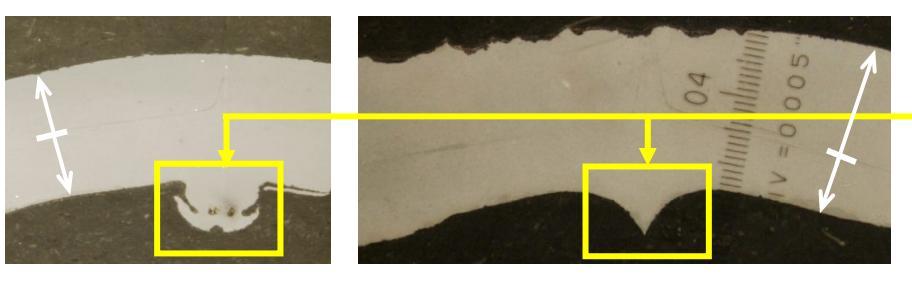
Example of used tubing for reference. Exposure of the acidic fluid will cause the longitudinal seam weld to degrade and produce scale.

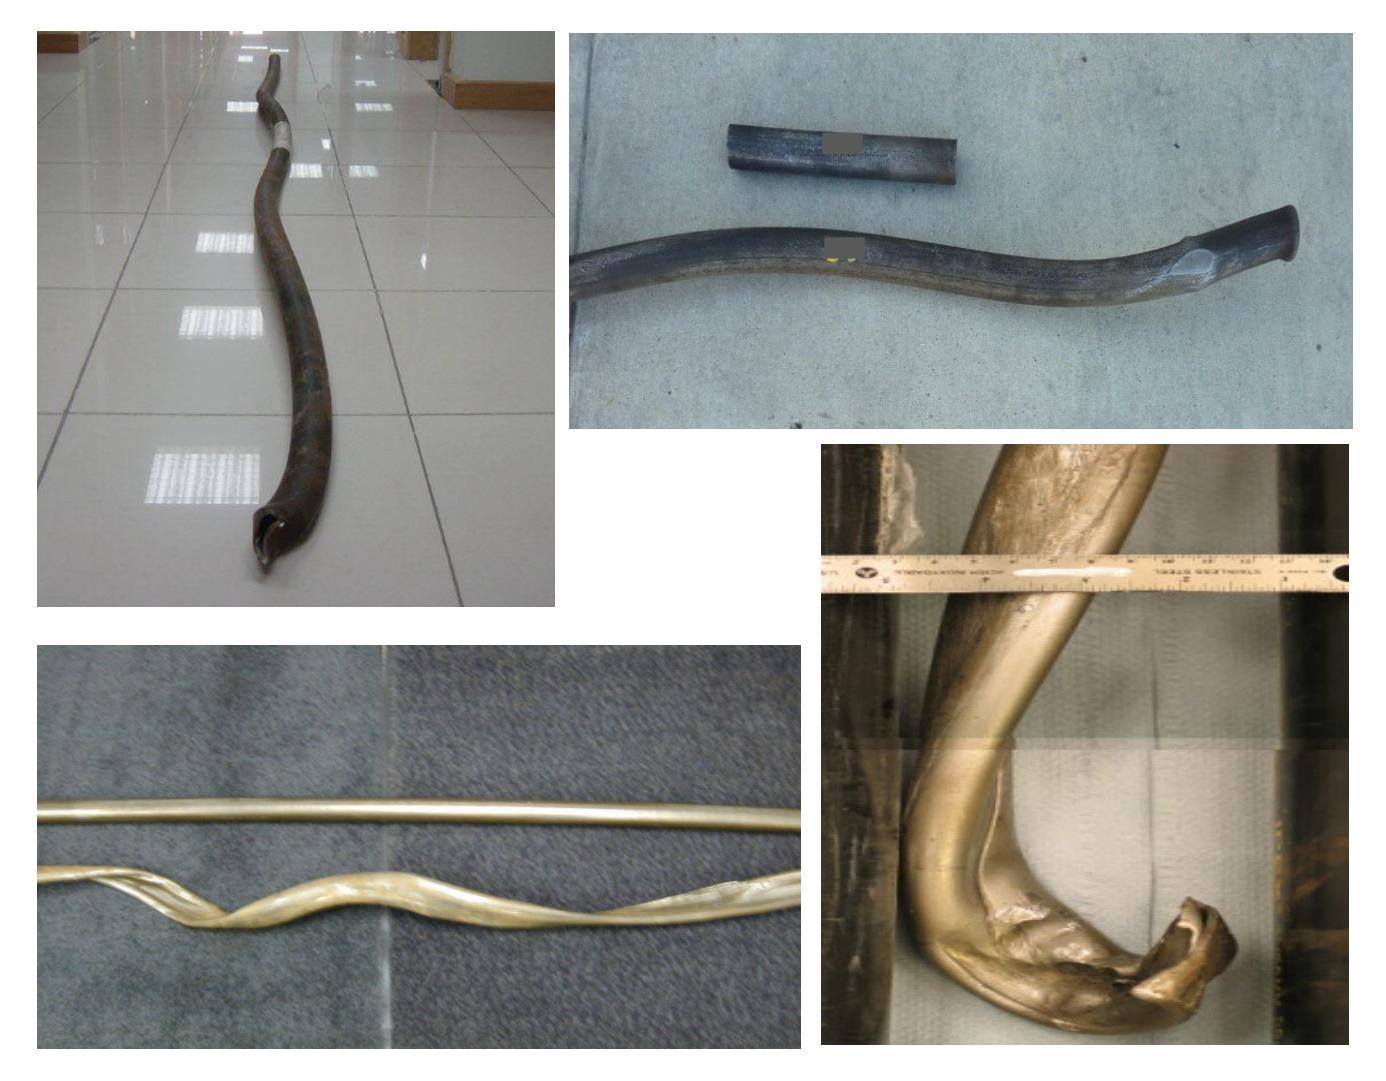
**EFFECT ON FATIGUE LIFE:** Corkscrew deformation is considered detrimental to the affected sections and continued use will lead to abrasive damage against the well tubing/casing which can substantially reduce the wall thickness.

**REPAIR:** Normally, this sort of damage is considered irreparable. Recommended action is to remove the corkscrewed sections.

**MTIGATION:** Correct motor selection based on max torque output and CT torque capacity is essential. When moving after a motor stall, reduce pump rate temporarily to reduce pressure and decrease any counter rotation. Monitor weight while RIH, especially during operations with large casing size compared to CT OD.

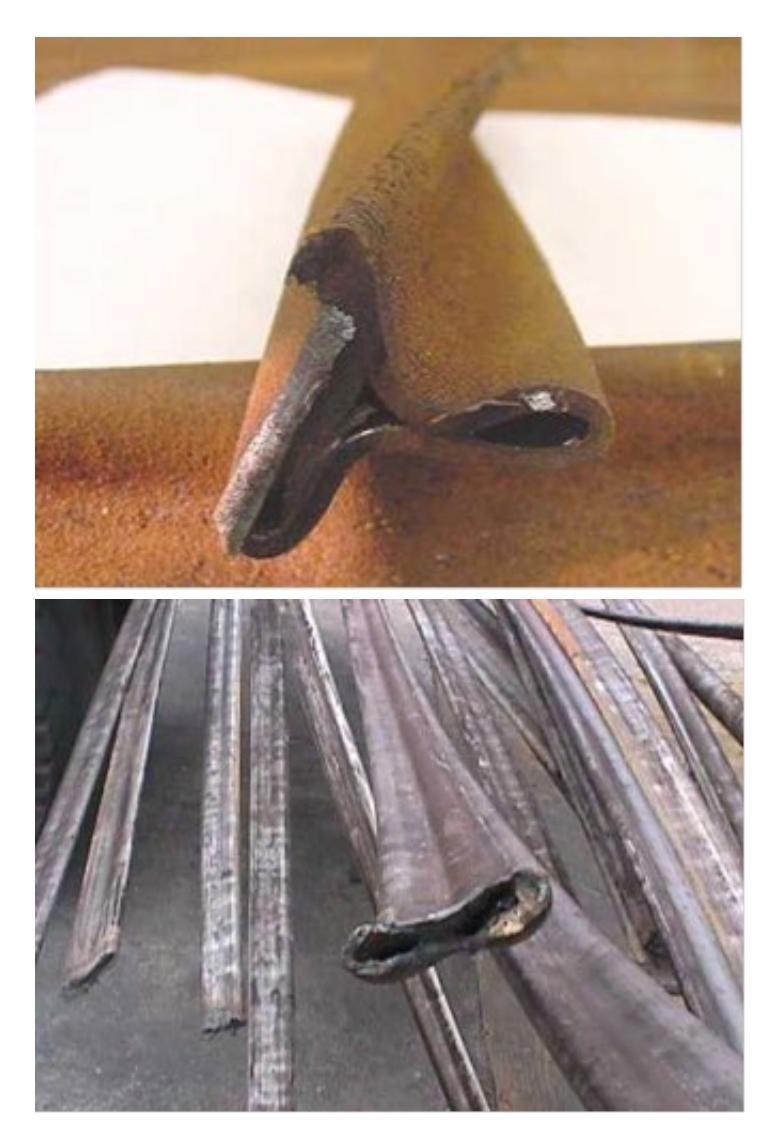
**DESCRIPTION:** The pressure differential between the annulus and tubing exceeds the allowable capacity of the tube. This causes the tube to collapse.

**REPAIR:** This sort of damage is considered irreparable. Recommended action is to remove the collapsed sections.

**MITIGATION**: Constantly monitor pressure and ensure conditions stay within acceptable von Mises stress limits. Consider that the worst-case condition may not be on surface, but downhole.

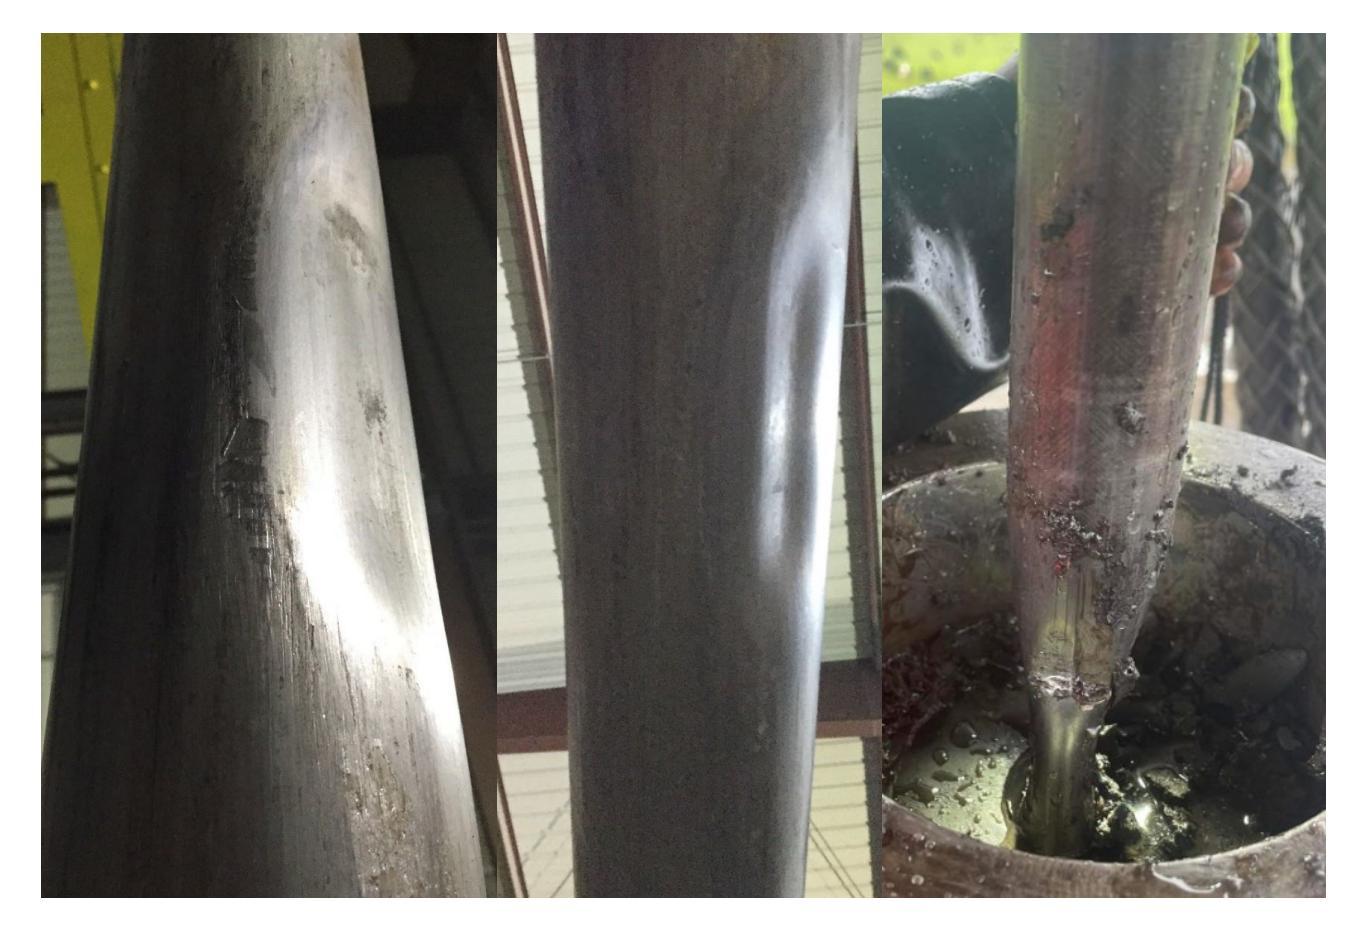
**POSSIBLE SOURCE:** Stripper packer failure lodged in between tube and stripper causing compressive damage to the tube surface. Debris build up inside the stripper pushes onto the CT OD, causing collapse.

**DESCRIPTION:** Stripper packer failure caused packer parts to lodge in between tube and stripper, leading to compressive damage on the tube surface. Debris can also build up at surface against the stripper while pulling out of hole and cause collapse.

**MITIGATION**: Ensure regular maintenance of the stripper and the lubricator is performed to prevent failure.

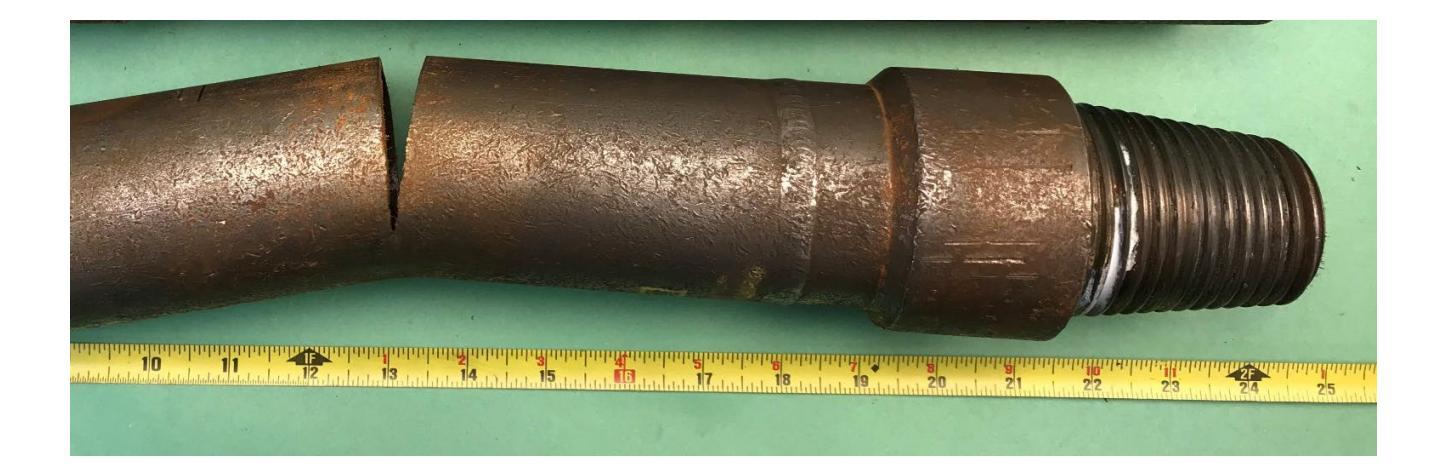
**PIN END FRACTURE/ABRASION FAILURE MITIGATION:** Failures immediately at the pin end of the BHA connector, or within proximity as shown below, are commonly caused by bent or kinked tubing not being cropped during BHA connector installation. A localized bend that causes additional stress at the connector can cause a premature bending failure as shown below. Cropping at a point where the tangent of the curve is perpendicular to the wellhead is critical.

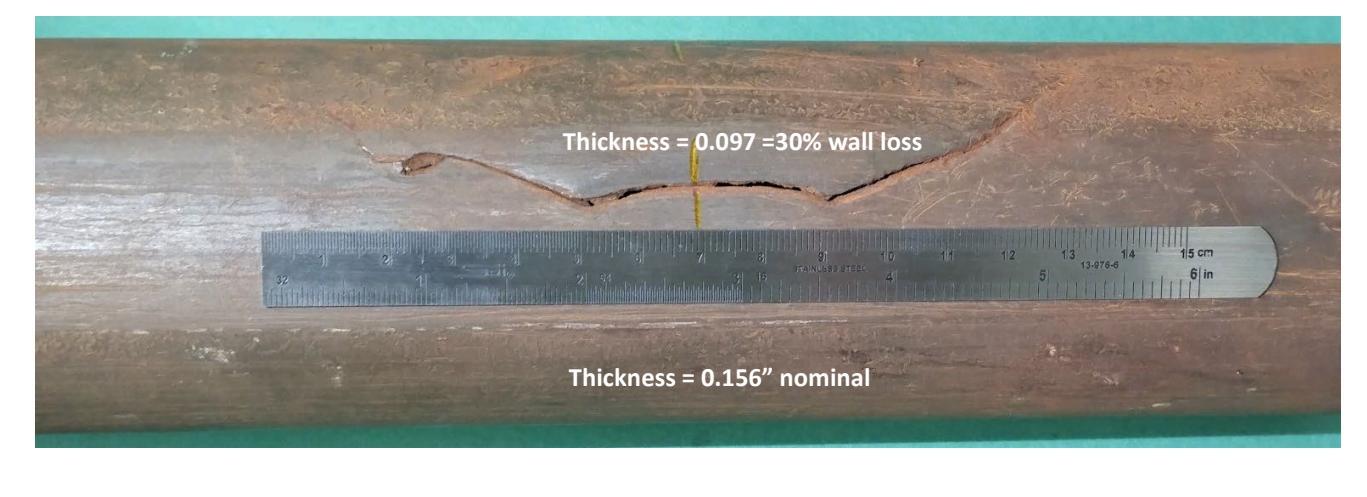
A localized kink or bend adjacent to the connector can cause high normal forces on the casing cause premature failure due to abrasion where the high normal forces caused by the kink selectively wear against the casing and cause a low wall thickness causing subsequent failure.
