# GLOSSARY OF COILED TUBING DAMAGE

Rev 20 7.17.24

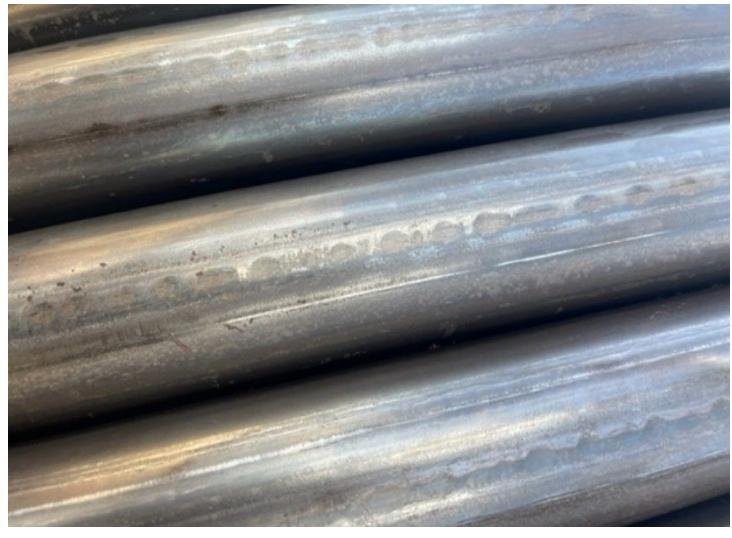
OD surface showing chatter markings on new tubing

**REPAIR and MITIGATION:** No repairs or mitigation are necessary.

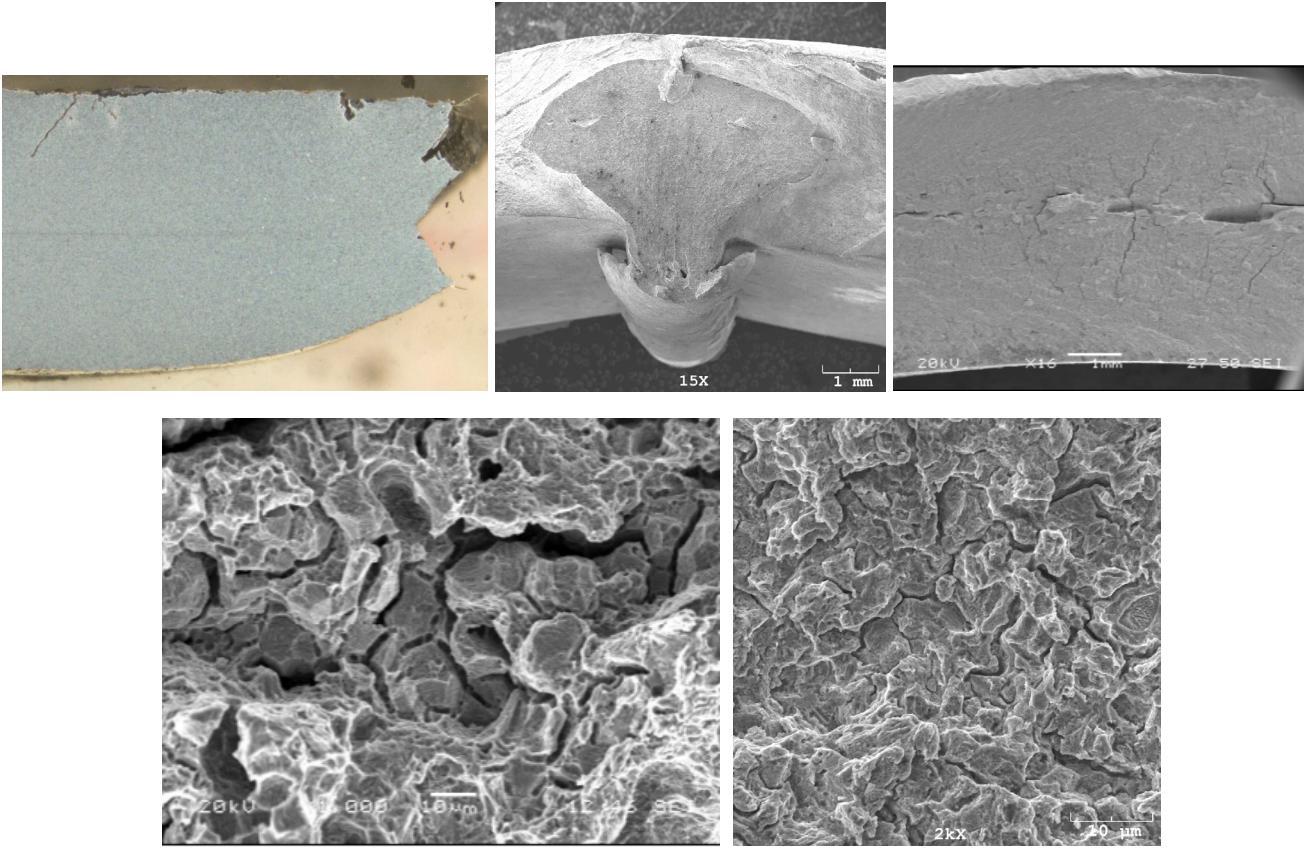
**EXAMPLES:** OD and ID cracking on the left, longitudinal weld seam in the center, and mid wall on the right, all have some characteristics of intergranular embrittlement shown at the bottom.

Intergranular Embrittlement is the microscopic signature of hydrogen embrittlemnt

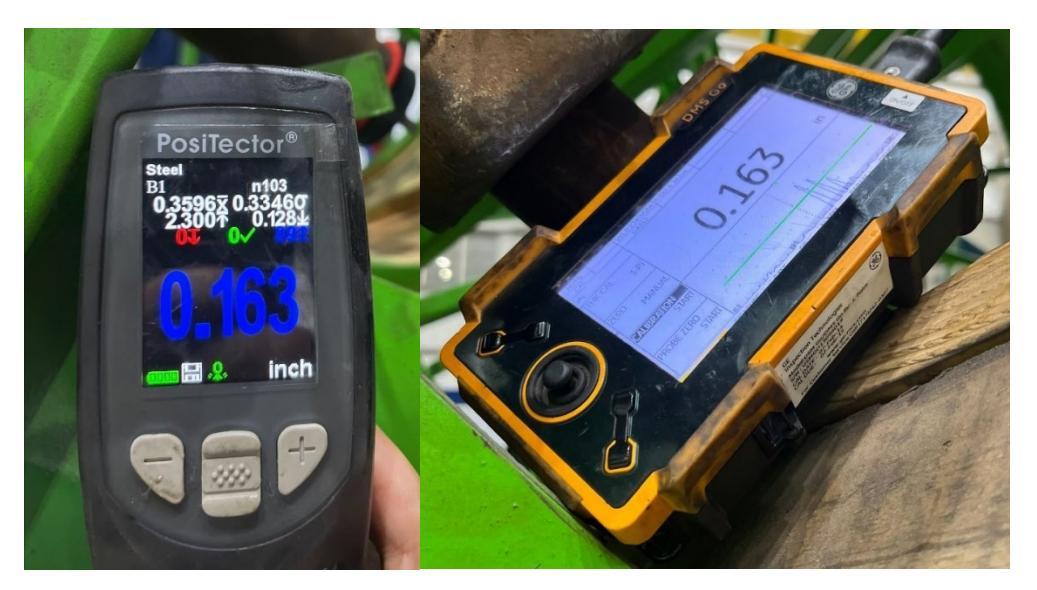
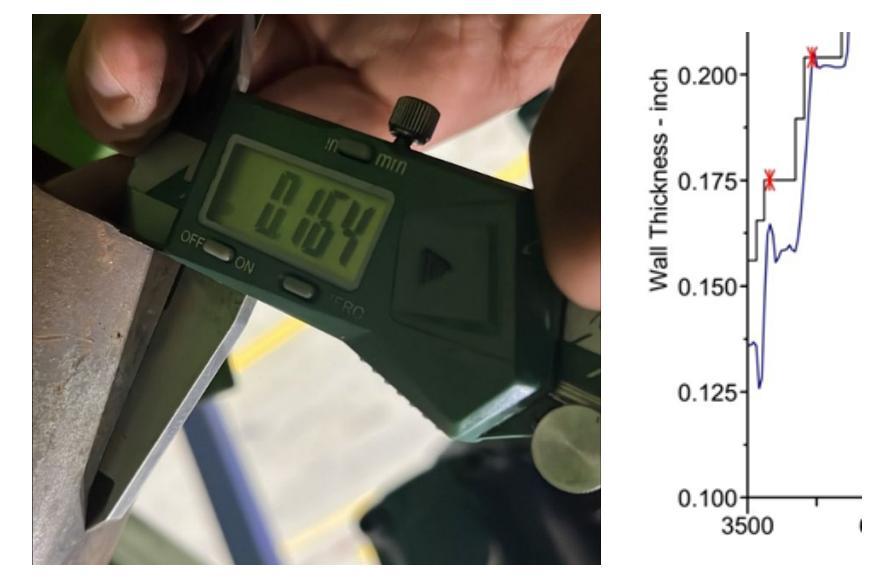
UT versus Hall Effect sensors and other thickness tools: In the example below, the Electromagnetic inspection tool showed a drastic reduction in wall thickness compared to the as milled properties: nearly 0.134" when the actual was 0.163". After inspection completion, the whip end was checked and measured 0.163 using a physical caliper and UT thickness measurements. The Electromagnetic tool was measuring 0.134". Validation with a physical device is critical, along with using the caliper correctly. Note the photo at the bottom is using the entire length of the device rather than just the tips of the caliper.
