Global Tubing

# GLOSSARY OF COILED TUBING DAMAGE

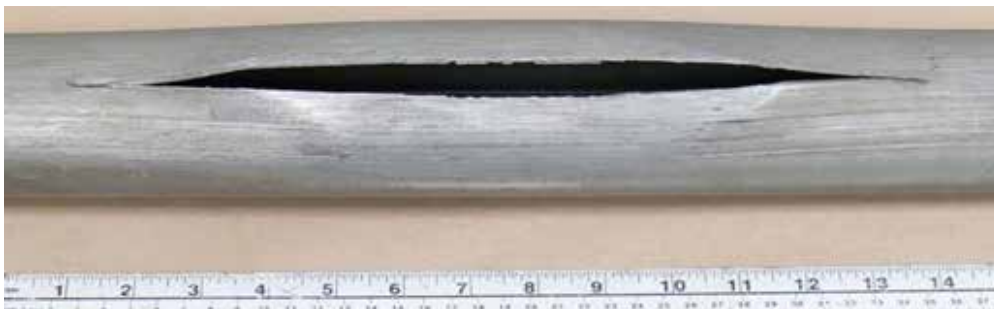
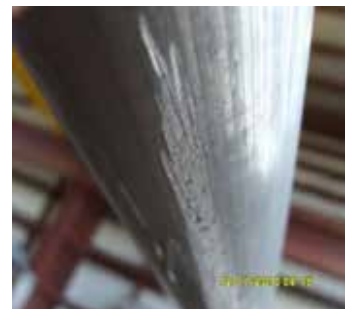
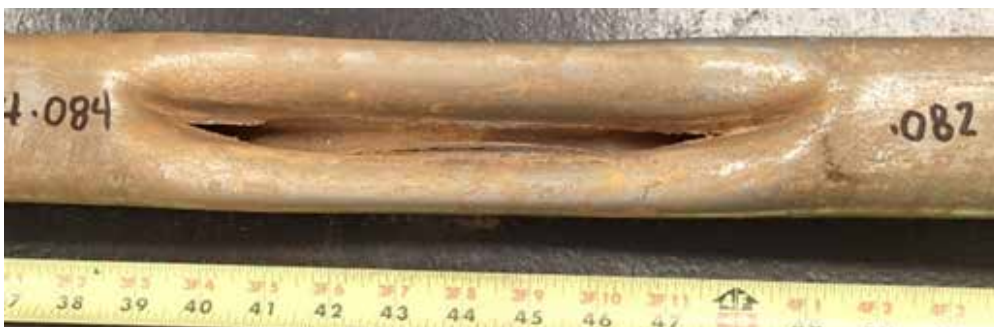
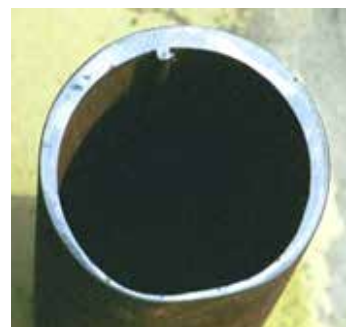
► **TYPE: Abrasion (Longitudinal Abrasion and Completion Abrasion)**

**POSSIBLE SOURCE:** Running into completion with high deviation, running into a completion with no fluid or other friction reducing agent, running into chrome completions, local bends in pipe near BHA.

**DESCRIPTION:** Abrasion damage can be a combination of galling and abrasive wear. Normally, the orientation of this damage is in the longitudinal direction.

**EFFECT ON FATIGUE LIFE:** Because the orientation of most completion damage is in the longitudinal direction, the detrimental effect on fatigue life due to the damage itself is minimal if the wall loss is minimal. The primary failure mode is burst or collapse as shown below.

**REPAIR:** Repairing longitudinal abrasion damage will have a minimal improvement in fatigue life. If wall thicknesses are within specification, it is better to not repair. If wall thickness are below specification, then it is recommended the section be removed completely.

**MITIGATION:** Constant pipe movement is essential especially when in the horizontal section of the well. Watch for abrasion, especially in close proximity to the coil connector. Trim pipe on a regular basis regardless of any indication of abrasion. Use of friction reducers can also reduce the propensity to this type of damage.

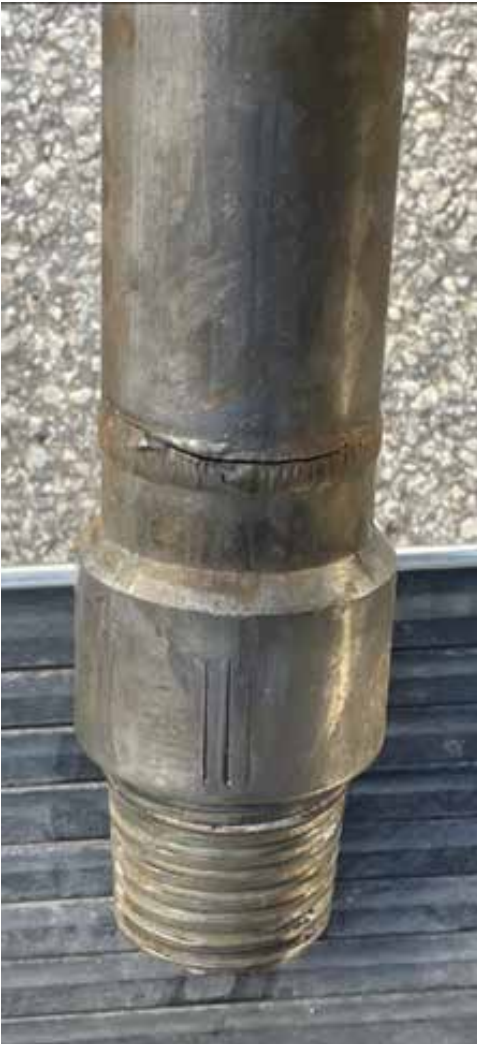
Weld Fracture

**POSSIBLE SOURCE:** BHA connector failures can come from several sources including welding technique, groove rolling technique, dimpling technique, tube cropping technique, localized abrasion etc.

**DESCRIPTION:** Partial failure or complete separation of the BHA from the UH portion of the tube.

**MITIGATION:** The following areas are addressed individually, Weld Failure, Groove/Dimple Failure, pin end connection failure, and abrasion failure.

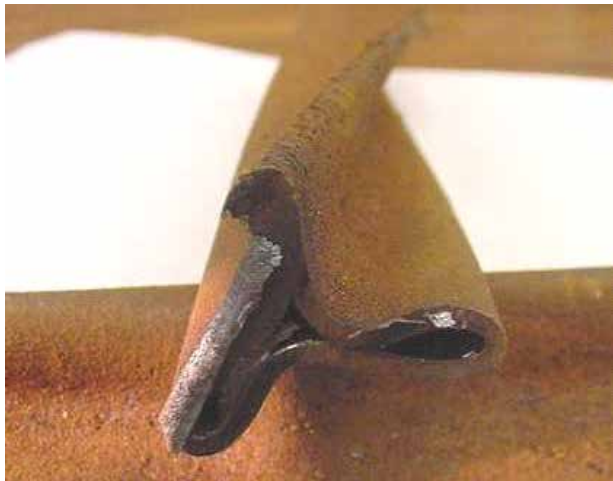
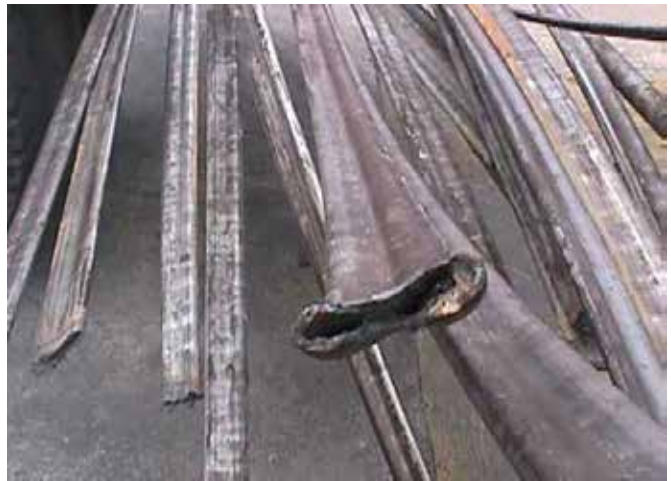
**▶ TYPE: Collapse**

**POSSIBLE SOURCE:** Over pressure in annulus, or reduction in wall thickness can initiate collapse.

**DESCRIPTION:** Annulus pressure exceeds capacity of tube.

**EFFECT ON FATIGUE LIFE:** Not Repairable.

**REPAIR:** Normally, this sort of damage is considered irreparable. Recommend action is to remove the collapsed sections.

**MITIGATION:** Constantly monitor pressure and ensure conditions stay within acceptable von mises stress limits. Keep in mind, that the worst-case condition may not be on surface, but downhole.

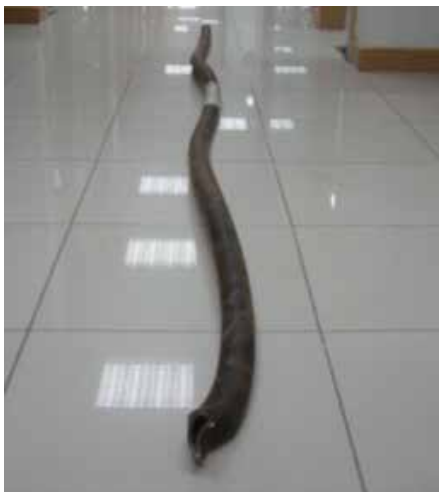
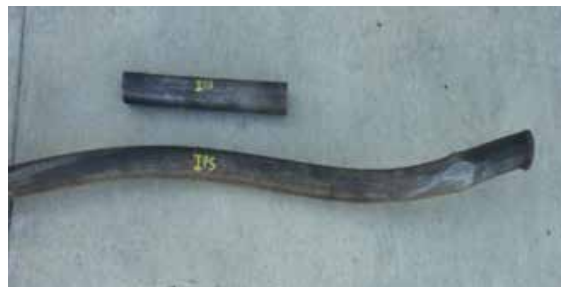
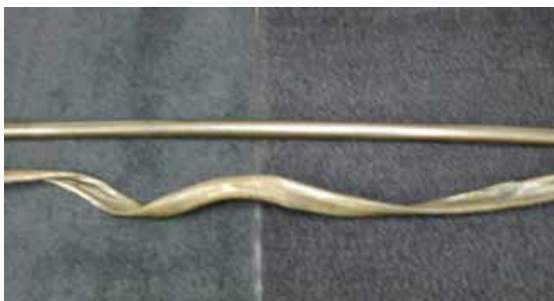
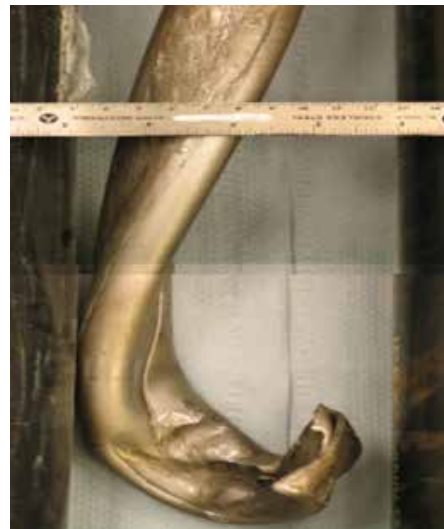
► **TYPE:** Corkscrew

**POSSIBLE SOURCE:** Over torque or sudden increase in compressive force that exceeds the limits of the tubing.

**DESCRIPTION:** Corkscrew is a type of deformation where the tubing is plastically deformed in a twisted shape.

**EFFECT ON FATIGUE LIFE:** Corkscrew deformation is considered detrimental to the affected sections and continued use will lead to abrasive damage against the well tubing/casing which can substantially reduce the wall thickness.

**REPAIR:** Normally, this sort of damage is considered irreparable. Recommended action is to remove the corkscrew sections.

**MITIGATION:** Correct motor selection based on max torque output and CT torque capacity is essential. When moving after a motor stall, reduce pump rate temporarily to reduce pressure and decrease any counter rotation. Monitor weight while RIH, especially during operations with large casing size compared to CT OD.

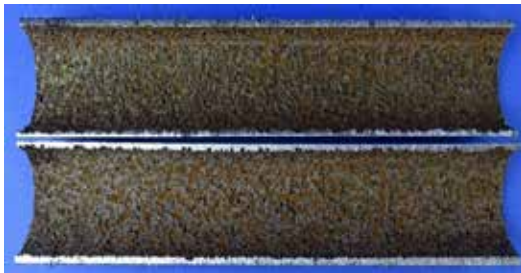
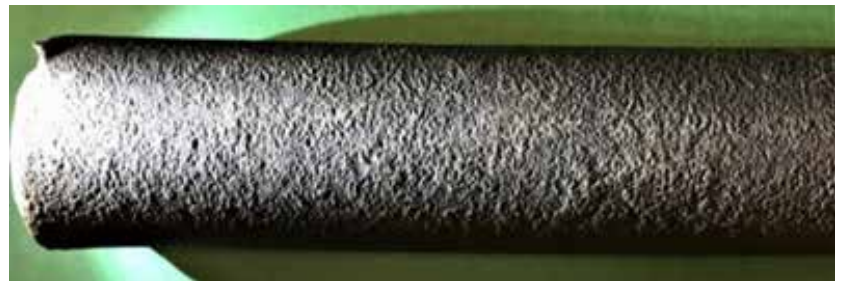
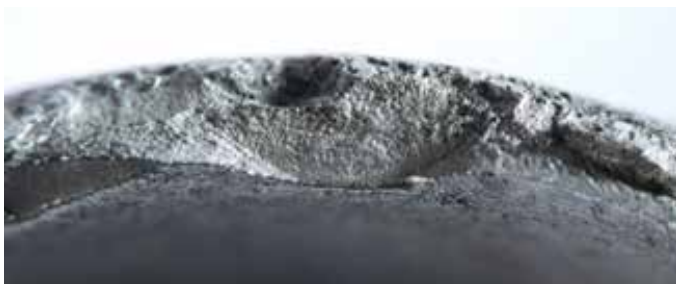
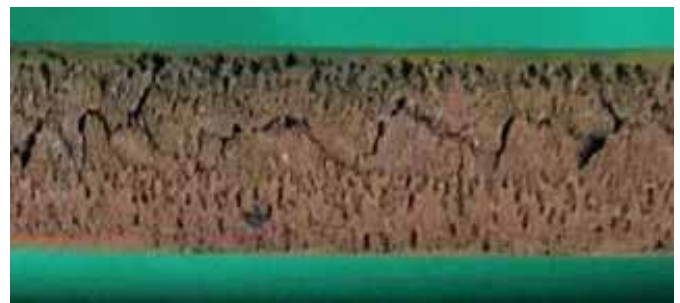
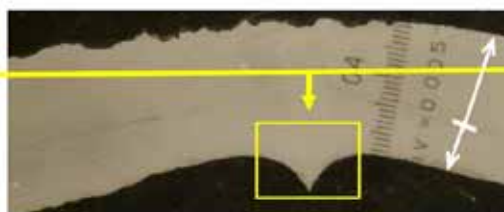
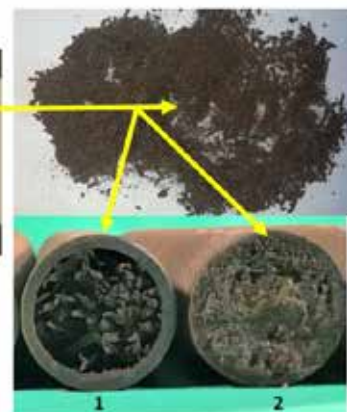
► **TYPE: Corrosion (Acid Corrosion)**

**POSSIBLE SOURCE:** The result of extended and unmitigated exposure to low pH (acidic) fluid. Improper and/or lack of adequate acid inhibition program allows for dissolution of CT material.

**DESCRIPTION:** Corrosion pitting comprised of multiple hemispherical overlapping pits. The pitting may severely reduce the wall thickness on either OD or ID surface depending on the exposed surface.

**EFFECT ON FATIGUE LIFE:** Not repairable.

Exposure of the acidic fluid will cause the longitudinal seam weld to degrade and produce scale.

**MITIGATION:** Proper chemical treatment and fluid management.

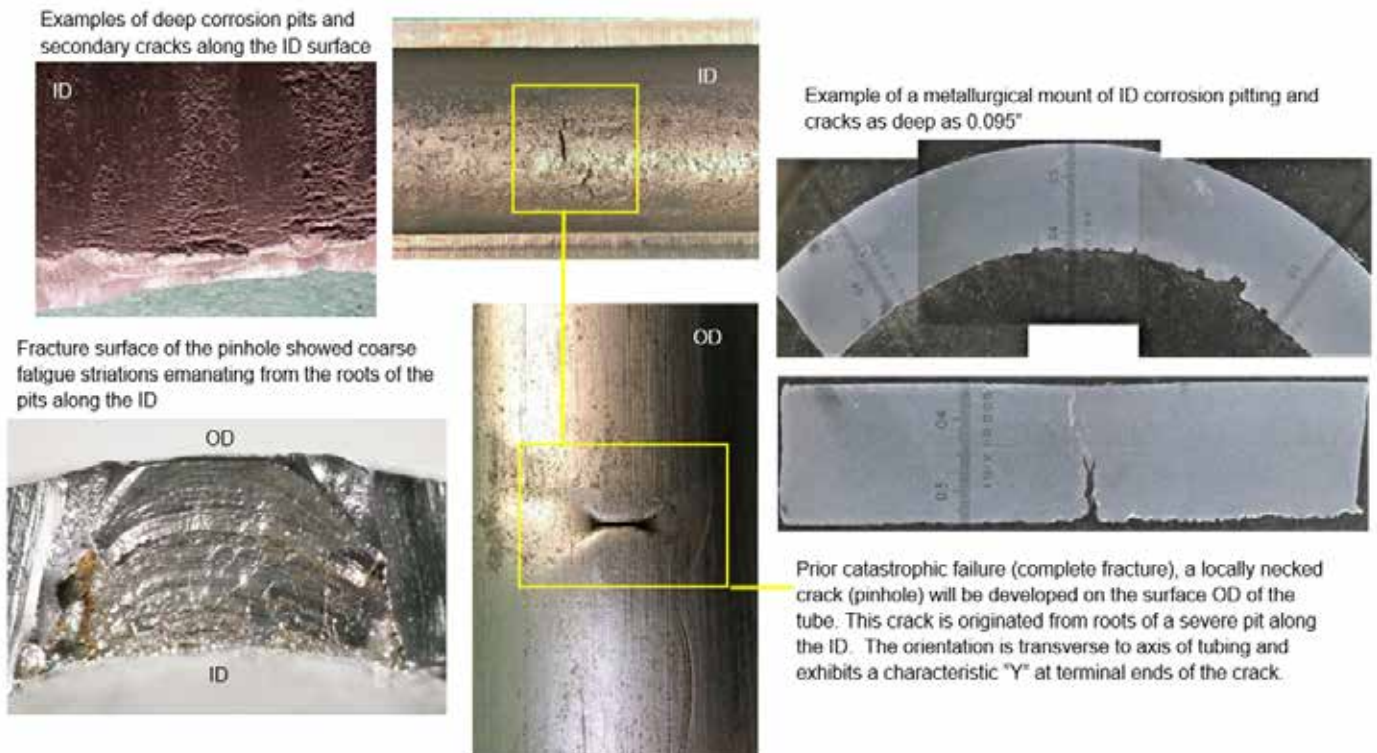
► **TYPE: Corrosion (Internal Corrosion)**

**POSSIBLE SOURCE:** Inadequate corrosion inhibition during job or improper storage after job with residual fluids inside, no purging procedure, uncapped ends during storage, and uninhibited fluids left from previous jobs.

**DESCRIPTION:** Internal corrosion from residual fluids or corrosive environment inside the string.

**EFFECT ON FATIGUE LIFE:** Corrosion can substantially reduce fatigue life because cracks propagate from the roots of the corrosion pits.

**REPAIR:** Normally, repair is not possible. Prevention and maintenance are the key to minimizing corrosion damage.

**MITIGATION:** Use a combination of wiper balls, wire brush pigs, biocides, inhibitors, and high-quality nitrogen to store strings between jobs. Proper chemical treatment will depend on the types of jobs performed, the fluids pumped, and the time between jobs.

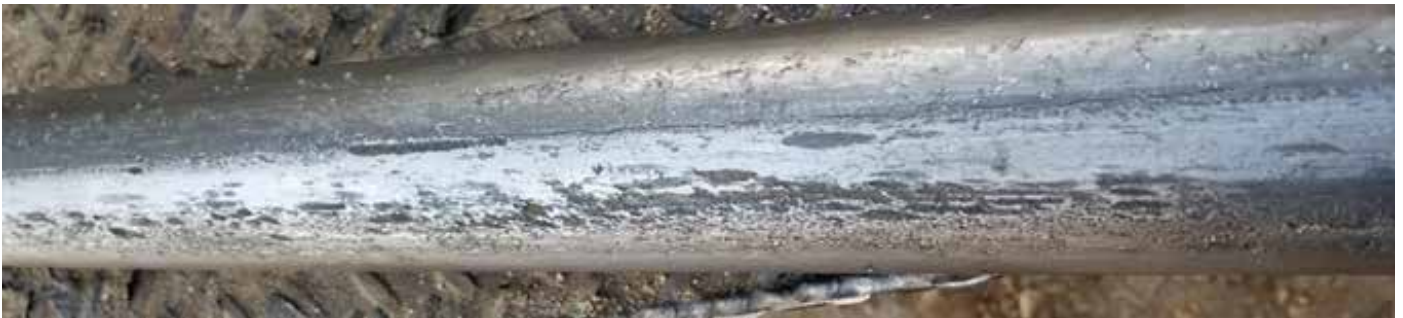
**▶ TYPE: Galling Damage**

**POSSIBLE SOURCE:** Abrasion from contact with casing and/or coupling

**DESCRIPTION:** Galling is a form of abrasion where adhesion of the two contact surfaces removes material and adheres the material upon the adjacent contact surface.

**EFFECT ON FATIGUE LIFE:** Not repairable.

**MITIGATION:** Monitor supplied coiled tubing material properties in comparison of existing casing material properties as well as use of friction reducers.

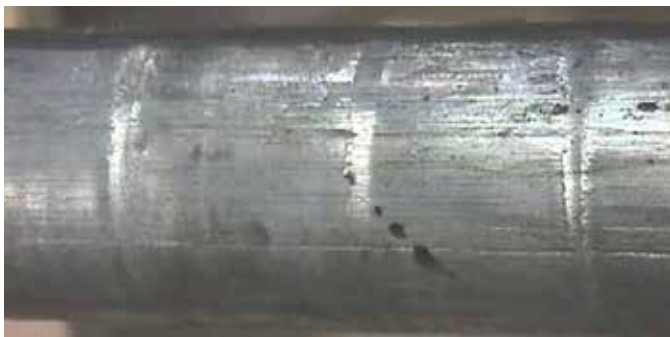
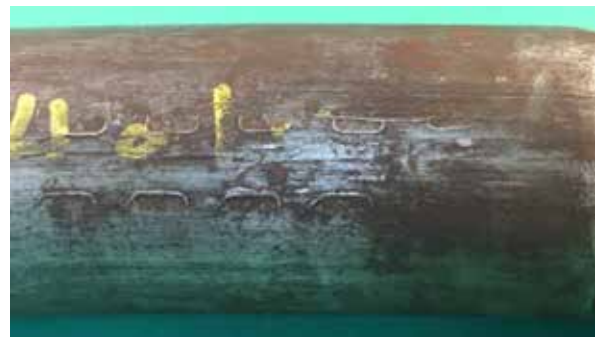
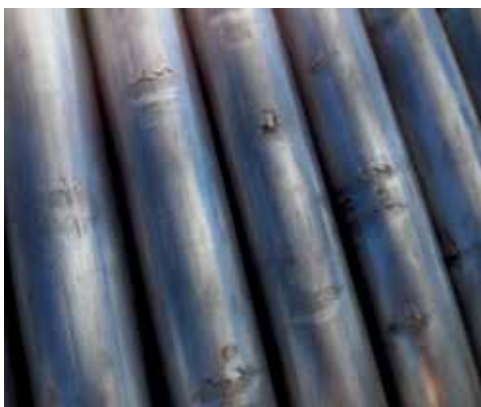
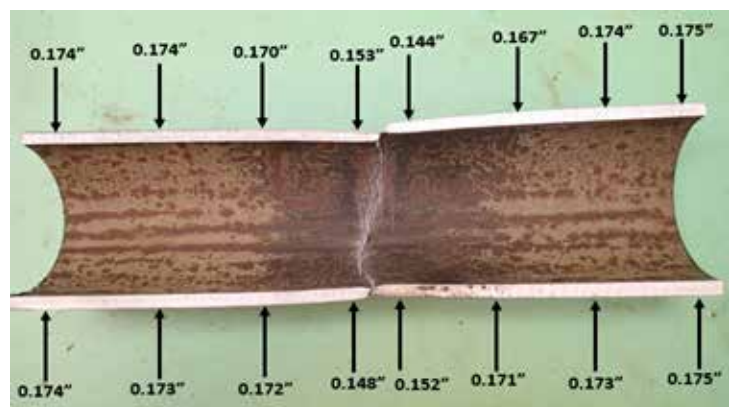
► **TYPE: Injector Damage**

**POSSIBLE SOURCE:** High injector chain pressure and loose chains during snubbing, injector shoe misalignment, Ballooning of pipe can cause interference between injector shoes and pipe

**DESCRIPTION:** Injector damage can be a combination of galling and abrasive wear. Normally, the orientation of this damage is in the transverse direction. The depth of the damage can be inconsistent depending on the tubing mechanical properties and injector parameters. Generally, damage of this type is shallow (<10% of base wall thickness) but can cause subsequent failure due to fatigue and subsequent wall reduction.

**EFFECT ON FATIGUE LIFE:** Transverse marks are detrimental to low cycle fatigue life. Normally, the shallow depth of such damage limits the reduction in fatigue life.

**REPAIR:** Repair of transverse injector damage is recommended when possible. Remove the damage per Global Tubing's "Field Damage Repair Guidelines" at the end of this document. However, many of these exceed 10% in depth or thin down with subsequent fatigue causing early failure.

**MITIGATION:** Follow injector head manufacturer's guidelines for chain tension based on snubbing forces seen during operations. As conditions change during operations, be sure to adjust chain tension.

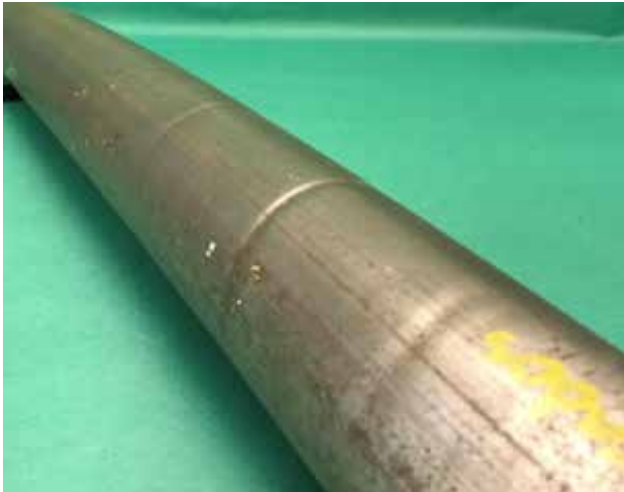
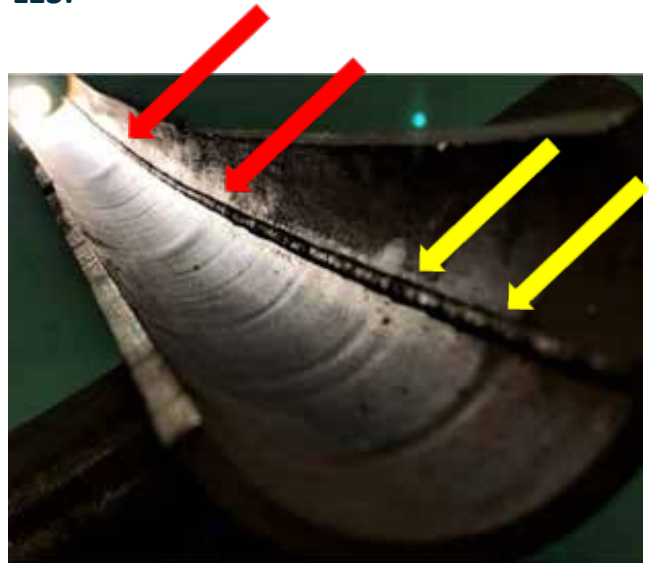
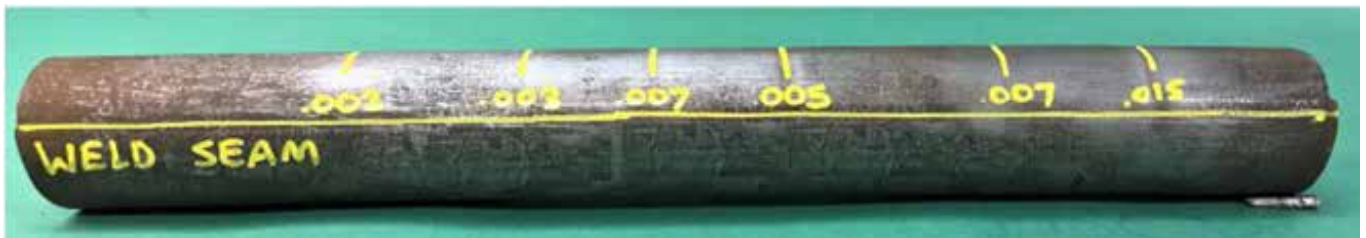
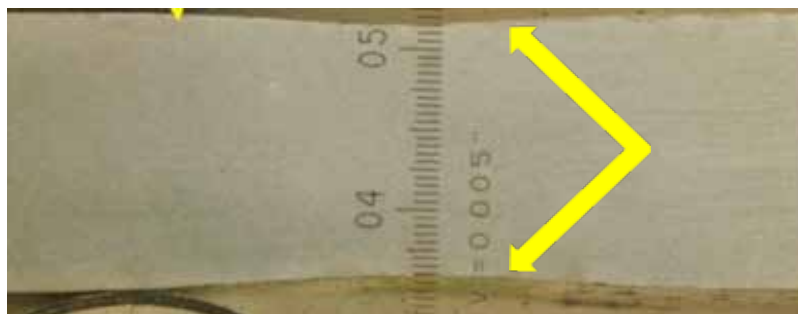
► **TYPE: Injector Damage (Semi-Circumferential Indentations)**

**POSSIBLE SOURCE:** Suspected source of damage is surface equipment

**DESCRIPTION:** Periodic OD indentations causes the ID to become smaller (red arrows) which causes a hinge effect and subsequent bending causes the wall thickness to neck down (yellow arrows).

**EFFECT ON FATIGUE LIFE:** Not repairable. Reduction in wall thickness and localized changes in hardness causes a reduction in tensile capacity.

**MITIGATION:** Frequent inspection of surface equipment and monitoring skate pressure and chain tension.

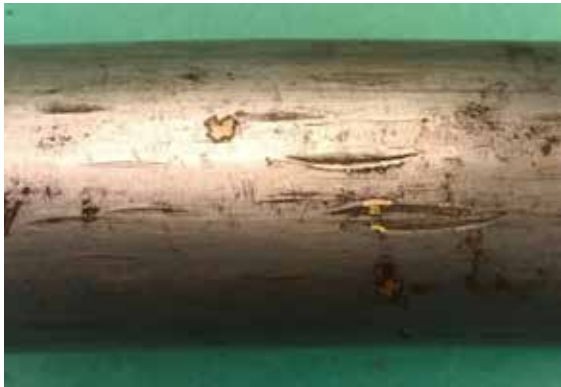
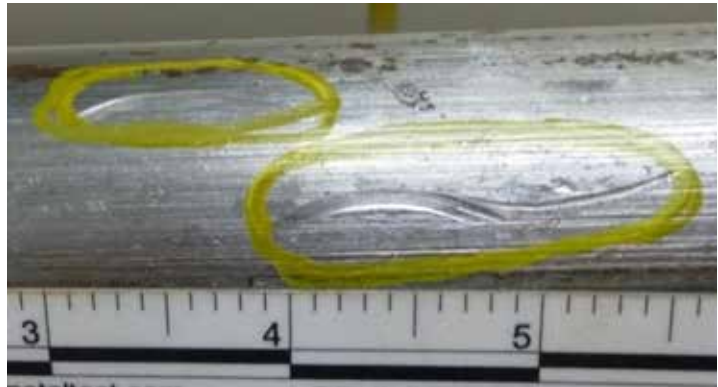
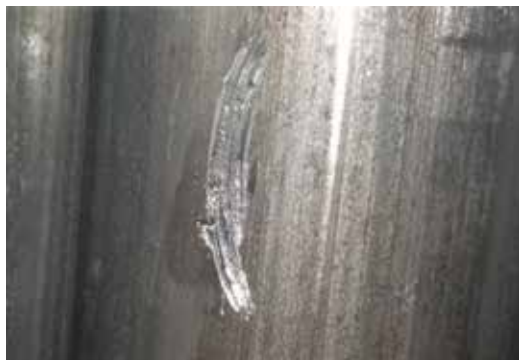
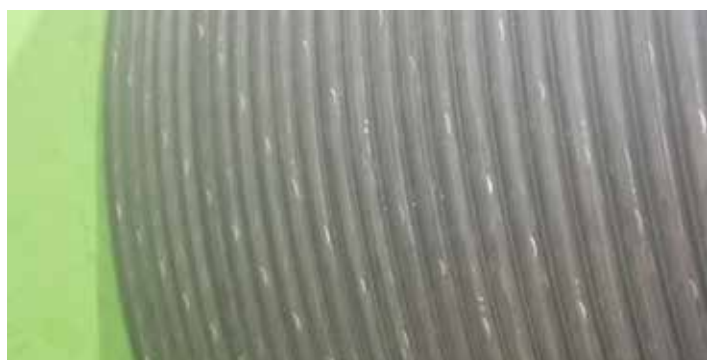
► **TYPE: Injector Damage (Crescent Moons or Swoop Marks)**

**POSSIBLE SOURCE:** Misaligned gooseneck, incorrect mounting of gripper block, wrong size of gripper block.

**DESCRIPTION:** Crescent moons are a form of abrasive/galling wear and are relatively smooth and uniform. This damage is imposed by the corner edge of coiled tubing injector head gripper blocks.

**EFFECT ON FATIGUE LIFE:** The orientation of this damage and the method of imposition result in minor reduction in low cycle fatigue life. Normally, the depth of this damage is less than 10% of the base wall thickness. More severe instances of this damage (10% or more of base wall thickness) may decrease fatigue life.

**REPAIR:** Repairing this damage type is recommended for the most severe cases. Remove the damage per Global Tubing’s “Field Damage Repair Guidelines” at the end of this document.

**MITIGATION:** GOOSENECK ALIGNMENT – Ensure gooseneck is properly aligned in relation to the coiled tubing unit, as well as the injector head itself. GRIPPER BLOCKS – Monitor gripper block condition and securement to the chains on a regular basis. Follow IH equipment manufacture guidelines for chain lubrication and gripper block securement.

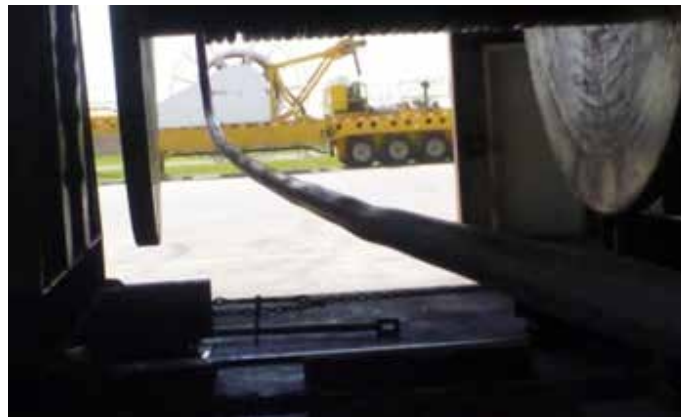
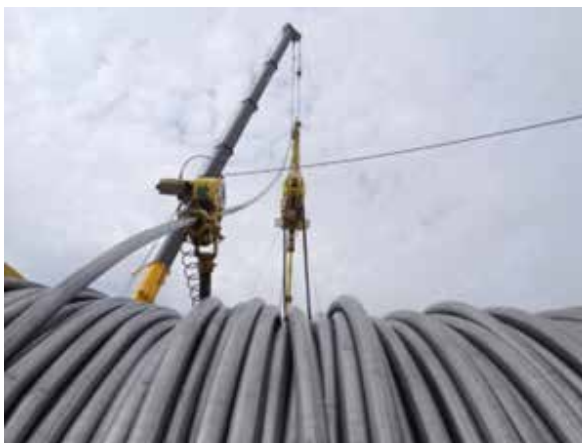
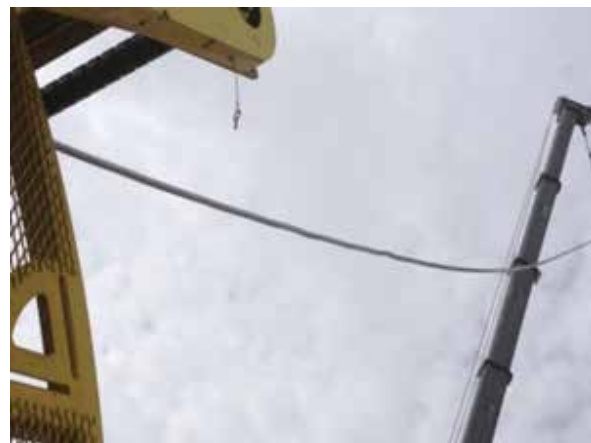
► **TYPE: Pipe Waviness**

**POSSIBLE SOURCE:** Loose or uneven wrap during spooling, gaps or overlapping wraps, flange interference causing overlapping and localized waviness.

**DESCRIPTION:** Waviness in the tubing is a type of deformation that is apparent by gradual undulation in the tubing. Waviness is a product of either poor wrapping quality (abrupt changes in the tubing wraps or gaps) or at crossovers (the change in spooling direction at the flanges).

**EFFECT ON FATIGUE LIFE:** Wave deformation is not considered detrimental to the mechanical properties of the tubing.

**REPAIR:** Subsequent plastic deformation (normal spooling) will reduce the appearance of this type of anomaly. Inducing a reverse bend will expedite removal of the wavy appearance.

**MITIGATION:** Use good spooling practices; wraps should be tight, and even throughout the reel. Avoid crossing over previous wraps and any gaps in the corners of the reel. Coiling similar to lower left photo should be avoided. Lubricate pipe on reel while spooling.

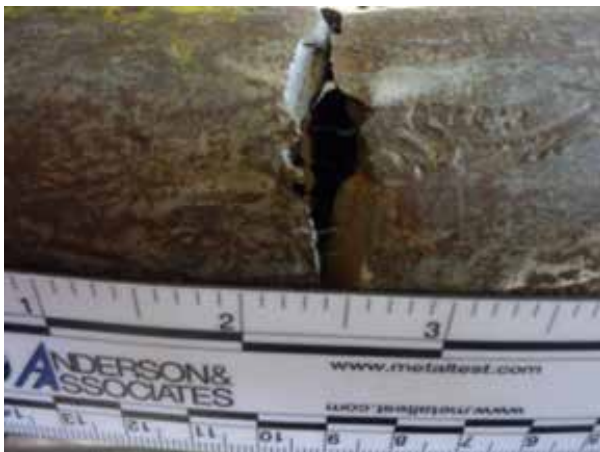
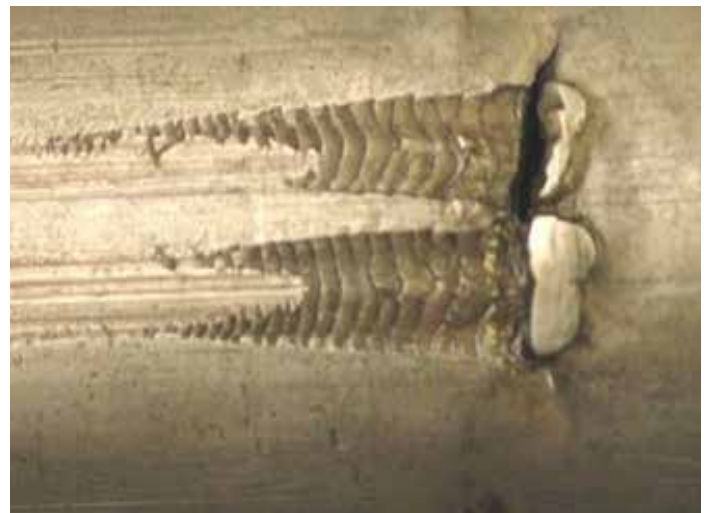
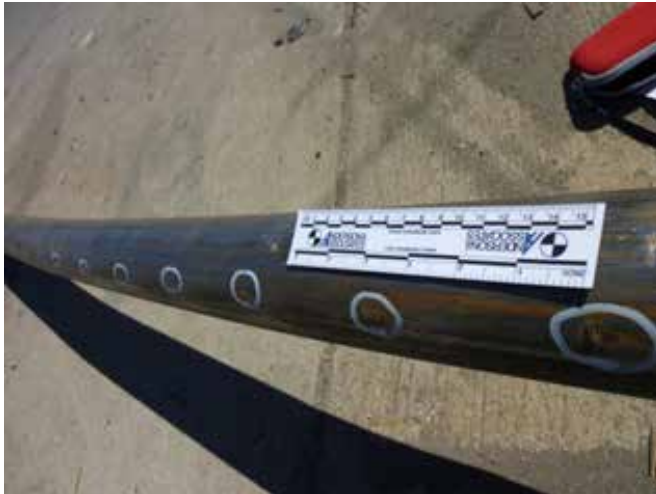
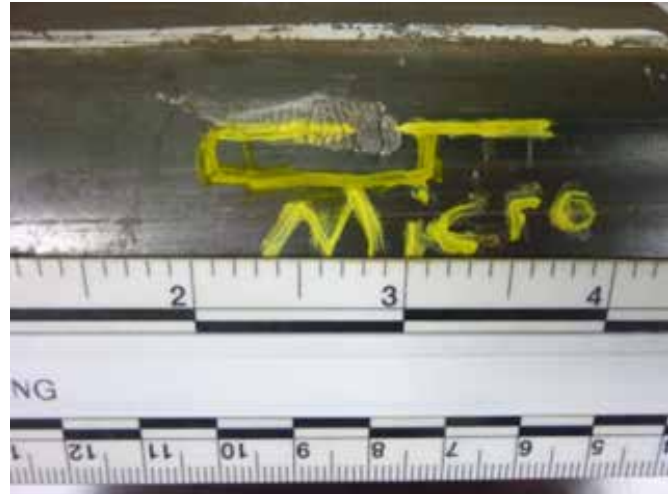
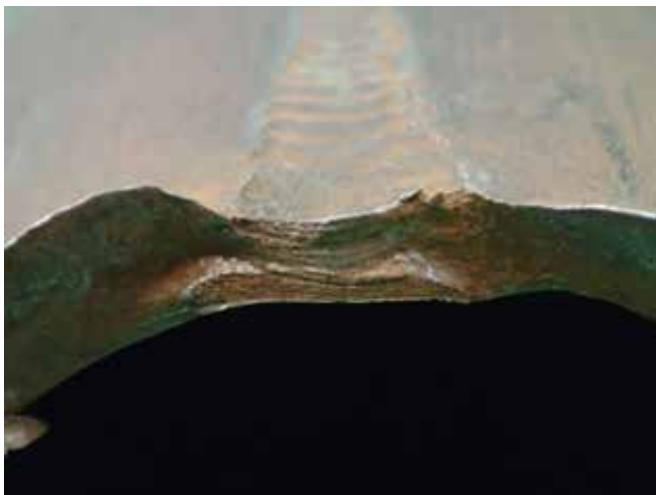
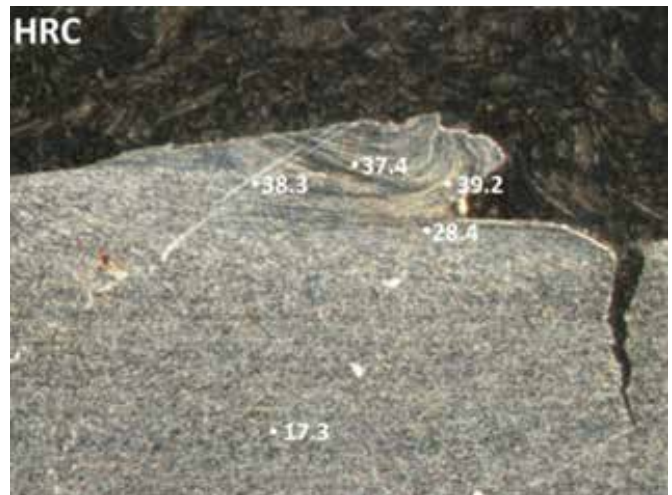
**▶ TYPE: Plow Marks (Fish Scale or Chatter Marks)**

**POSSIBLE SOURCE:** Injector head gripper blocks, downhole debris, well completion components

**DESCRIPTION:** Injector damage can be a combination of galling and abrasive wear. Normally, the orientation of this damage is in the transverse direction. The depth of the damage can be inconsistent depending on the tubing mechanical properties and injector parameters. Generally, damage of this type is shallow (<10% of base wall thickness) but can cause subsequent failure due to fatigue and subsequent wall reduction.

**EFFECT ON FATIGUE LIFE:** Transverse marks are detrimental to low cycle fatigue life. Normally, the shallow depth of such damage limits the reduction in fatigue life.

**Plow Marks:** Note the increase in hardness and fractures emanating from the root of the mechanical damage. Immediate repair is critical to reduce the amount of cracking at the root of this damage followed by non destructive examination such as Magnetic Particle or Liquid Penetrant Inspection to assure complete removal of the cracking.

**REPAIR:** Repair of transverse injector damage is recommended when possible. Remove the damage per Global Tubing's "Field Damage Repair Guidelines" at the end of this document. However, many of these exceed 10% in depth or thin down with subsequent fatigue causing early failure.

**MITIGATION:** Follow injector head manufacturer's guidelines for chain tension based on snubbing forces seen during operations. As conditions change during operations, be sure to adjust chain tension.

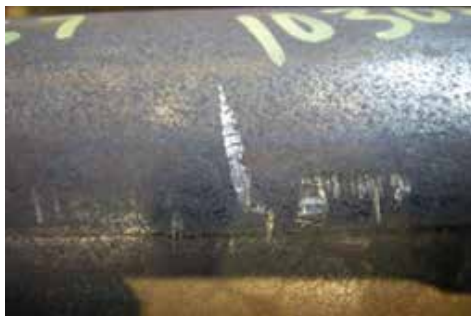
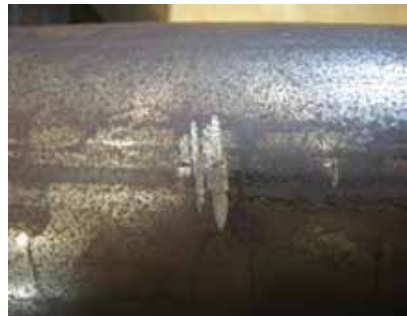
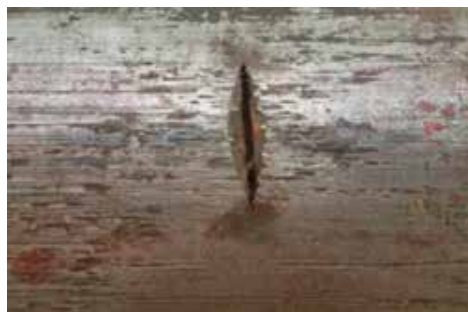
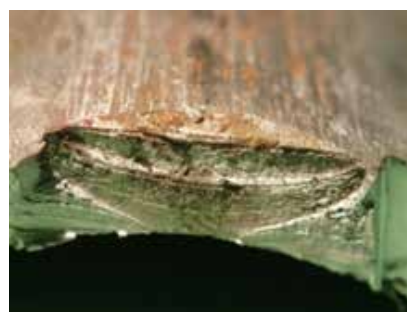
**▶ TYPE: Spooling Damage**

**POSSIBLE SOURCE:** Tight wrapping during spooling especially while making the change from one layer to the next, spooling while the tubing is dry, yard spooling with large angle from one spool to the other, loose spooling of the tubing, misalignment of gooseneck while reeling.

**DESCRIPTION:** Spooling damage is normally transverse galling. The orientation of this damage on the tubing is generally either the outer surface of the tube, or 90 degrees from the outermost surface of the tubing while on the spool. The depth of spooling damage ranges from 0-20% of base wall thickness. High grade (90+ksi yield strength) and large OD (2" +) have a greater propensity for spooling damage due to increased contact forces involved during spooling.

**EFFECT ON FATIGUE LIFE:** The orientation of this damage on the tube effects fatigue life. Because the damage is transverse, the reduction in low cycle fatigue life is moderate. Quantifying the reduction in fatigue life is difficult due to the varying depth and length of damage.

**REPAIR:** Repairing spooling damage is recommended. Remove the damage per Global Tubing's "Field Damage Repair Guidelines" at the end of this document. Check for cracking after repair by MPI or LPI after spooling to assure the entire crack is removed.

**MITIGATION:** Use good spooling practices. Wraps should be tight, and even throughout the reel. Avoid crossing over previous wraps and any gaps in the corners of the reel. Lubricate pipe on reel while spooling. seen during operations. As conditions change during operations, be sure to adjust chain tension.

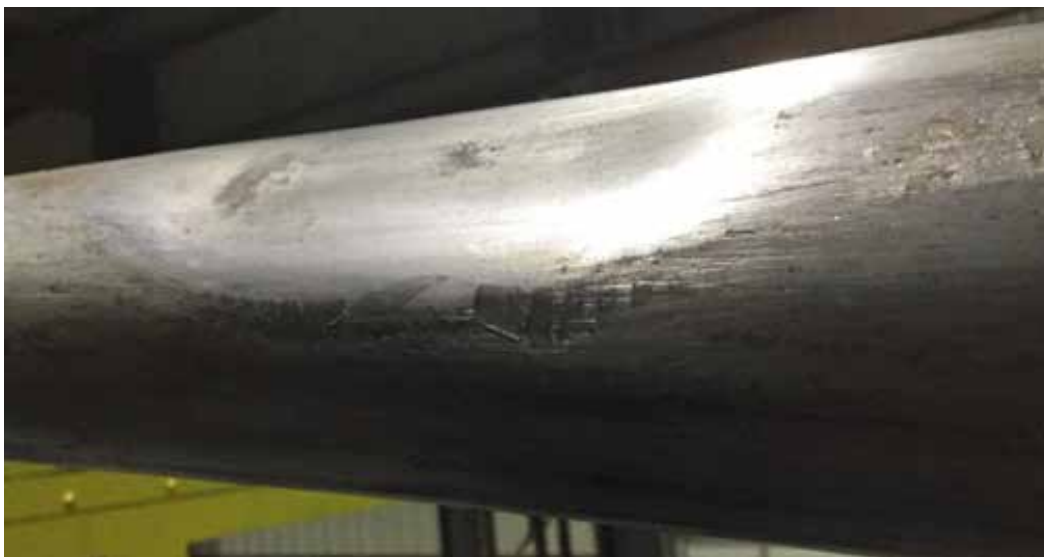
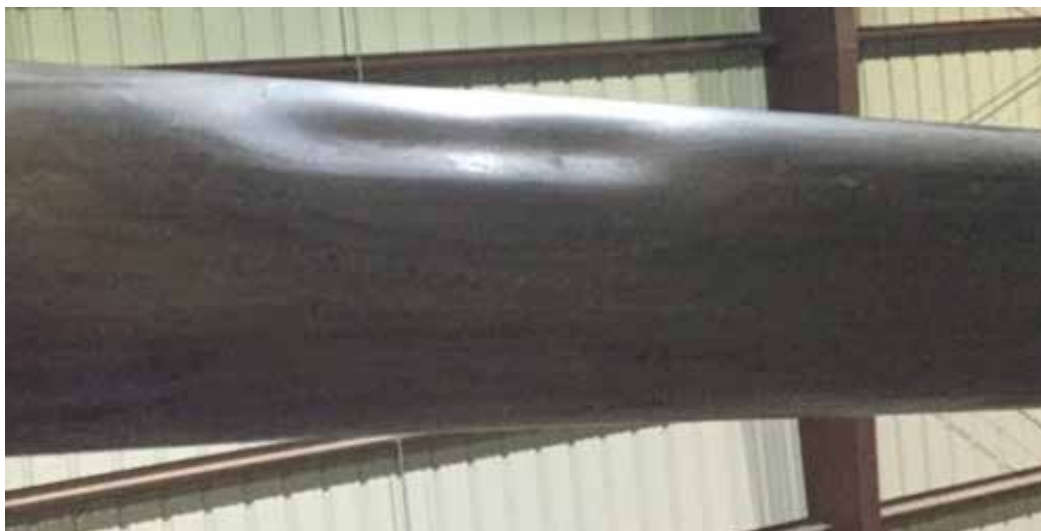
**▶ TYPE: Stripper Failure**

**POSSIBLE SOURCE:** Stripper packer failure lodged in between tube and stripper causing compressive damage on tube surface.

**DESCRIPTION:** Stripper lubricator failed and packer dried out causing failure. A section of the stripper spalled off and wedged in between the tube and the stripper causing multiple dents in the tube as it was running in hole.

**EFFECT ON FATIGUE LIFE:** Not Repairable.

**MITIGATION:** Assure maintenance of the stripper and the lubricator to prevent failure.

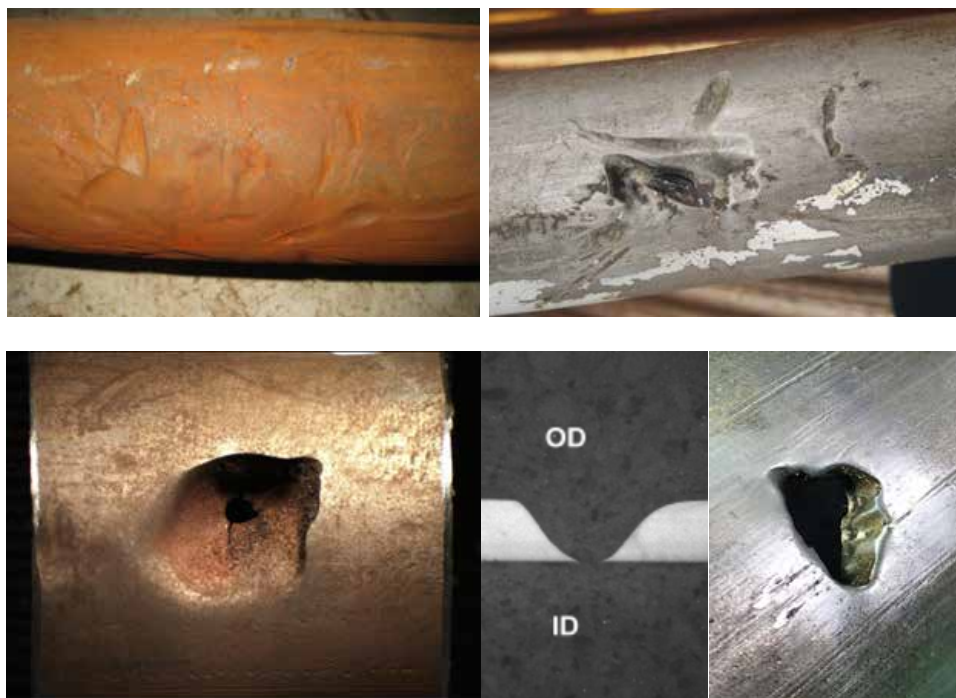
► **TYPE: Washout / Erosion**

**POSSIBLE SOURCE:** Static coiled tubing downhole in close proximity to perforations, flow tees, broken casing collars, or other jetting sources with sand (or other abrasive) and fluid. Move string frequently to prevent localized abrasion.

**DESCRIPTION:** Washout damage is a type of erosive wear. Washouts are typically very smooth and non-uniform in shape and depth. They are also independent of tube grade and hardness.

**EFFECT ON FATIGUE LIFE:** Washout damage reduces fatigue life by reducing the tubing wall thickness. The smooth nature of washout damage is less detrimental than damage of the same depth with jagged, point contacts, but because the shape and depth of washouts are impossible to predict, the reduction of fatigue life is also difficult to predict. Most likely, the reduction in fatigue life is large due to the aggressive nature of erosion.

**REPAIR:** Normally, this sort of damage is considered irreparable. If chosen to remove the damage, use Global Tubing’s “Field Damage Repair Guidelines” at the end of this document, or remove completely and perform a tube to tube butt weld.

**MITIGATION:** Keep pipe moving at all times during the operation, especially when cleaning/returning a high volume of abrasive debris or taking returns at a high velocity. Using a flow cross instead of a flow tee at the well head which allows for multiple fluid flow paths and reduces the chances of flow path impingement.
