Abrasion Mitigation

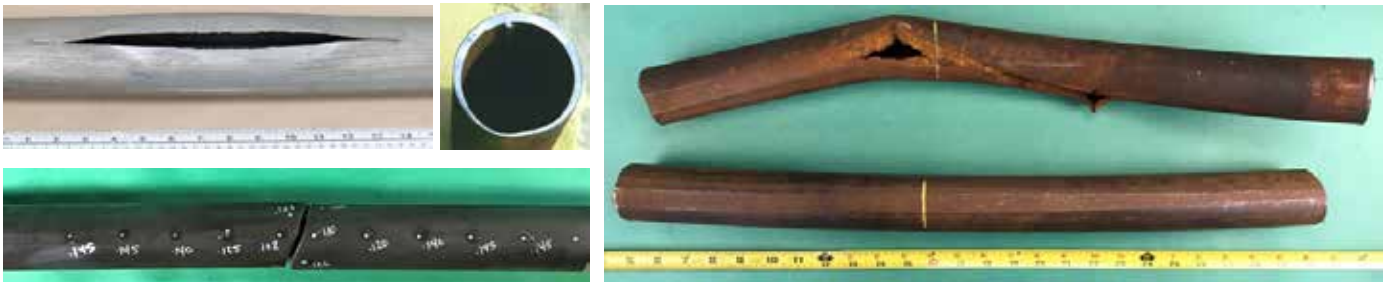
A combination of galling and abrasive wear from contact between the tubing and well completion casing can cause abrasion. Generally, the orientation of this damage is along the longitudinal axis of the tubing.

The following images are examples of the damage in the outer surface of the coiled tubing.

Due to abrasion damage being commonly sustained in the longitudinal direction, the detrimental effect on fatigue life is directly correlated with the amount of wall thickness loss. The primary failure mode is burst or collapse as shown below.

- Minimize localized bends and kinks near the BHA to minimize localized buckling and high contact forces near extended reach tools. Visually inspect near the BHA for flat spots or abrupt changes in ovality and crop as necessary.
- Implement a consistent BHA cropping and assessment procedure regardless of any indication of abrasion to minimize the possibility of a flat spot being close to the BHA. The field may trim 30 - 50 ft routinely to assure flat areas are removed.
- Uniform spooling during operations will minimize localized bends and kinks at crossovers which can cause localized abrasion.
- Use of lubricants will reduce abrasion rates, but the timing must be considering based on tubing forces and hydraulics analysis, particularly when the highest wall contact forces may be experienced.
