# GLOSSARY OF COILED TUBING DAMAGE

Rev 20 7.17.24

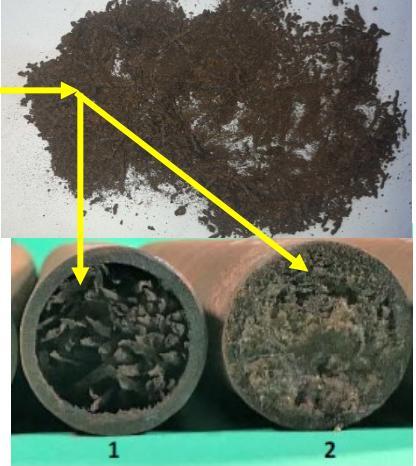
Example of used tubing for reference. Exposure of the acidic fluid will cause the longitudinal seam weld to degrade and produce scale.

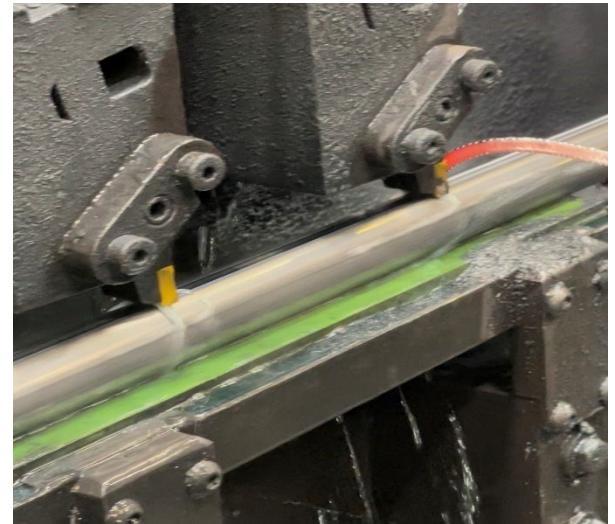
OD surface showing chatter markings on new tubing

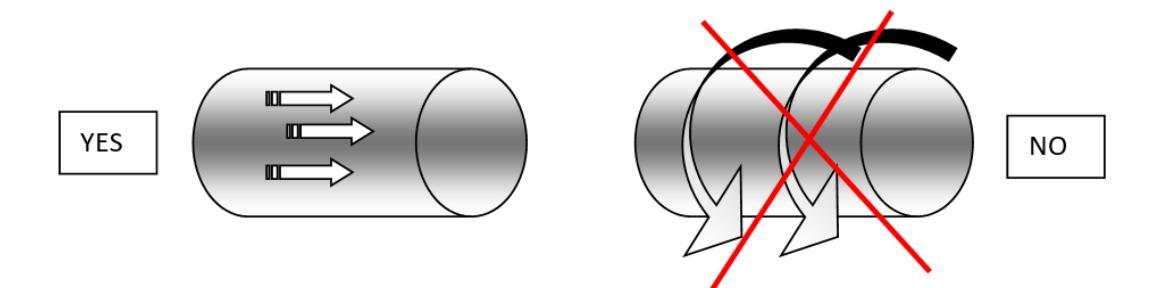
Figure 1: Correct (left) and Incorrect (right) sanding directions.

- 1) Using manual or power tools, remove surface material from the tubing to expose and eliminate the flaw.
  - a. Regardless of the type of tool used, pay attention to the **<u>DIRECTION of HOW</u>** the material is removed. See **Figure 1**.
  - b. Sanding media used to remove the material from the surface should only move in the direction parallel with the length of the tubing and never at any angle. Circumferential sanding marks due to initial sanding shall be removed in the longitudinal direction during final sanding.

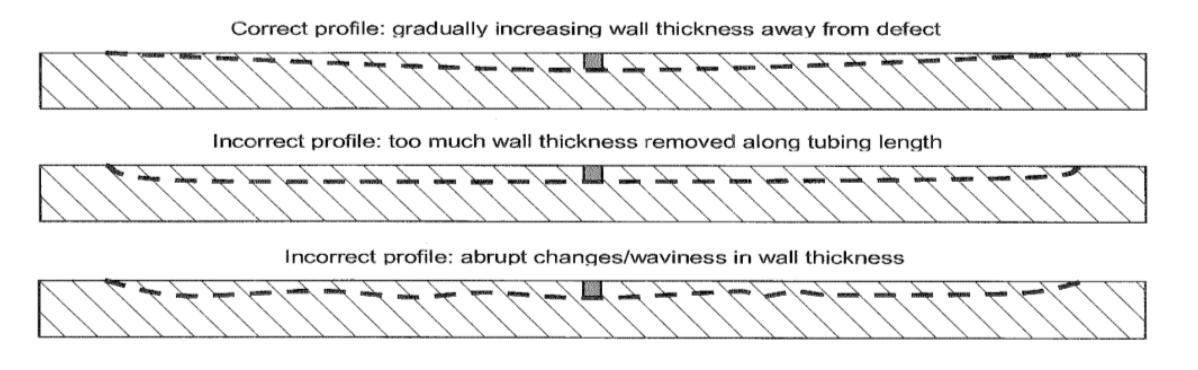
Figure 3: Tube profile examples after defect removal. Take note that the gradual profile change is preferred as seen in the top illustration. While the bottom two illustrations show undesirable profiles with abrupt changes and transitions in wall thickness.

f. Figure 3 illustrates the proper and improper profiles of the final surface after repair.

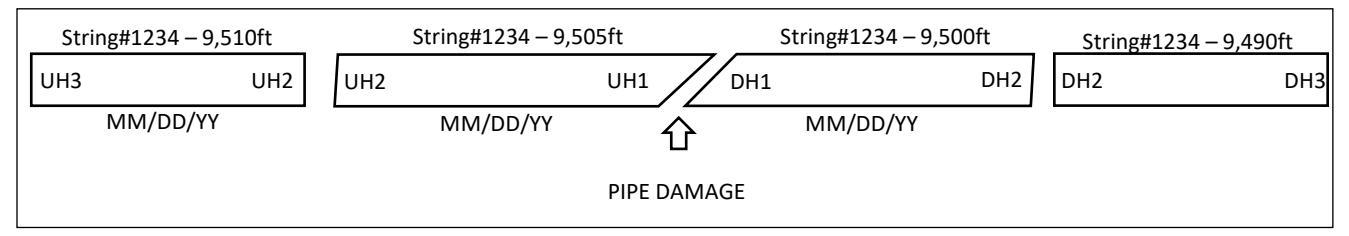
#### Figure 4: Example of a break fracture, with proper labeling of failure samples to be sent for analysis.

If multiple samples are taken from a string, their matching faces should be designated with uphole (UH) and downhole (DH), with sample depths, date, and labels as shown below in **Figures 4 and 5**.

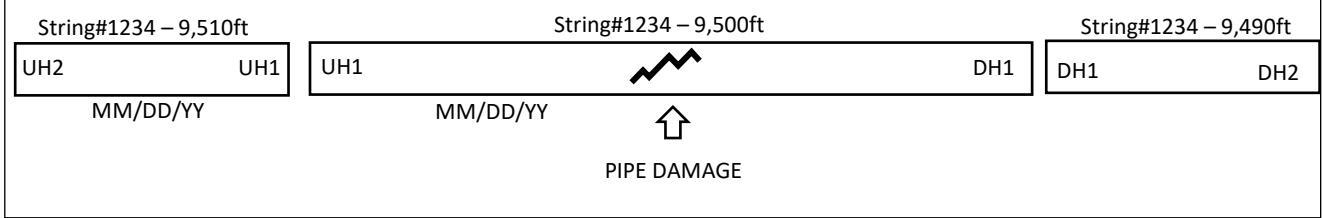
Figure 5: Example of a damaged section, with proper labeling of failure samples to be sent for analysis.
