Global Tubing

# GLOSSARY OF COILED TUBING DAMAGE

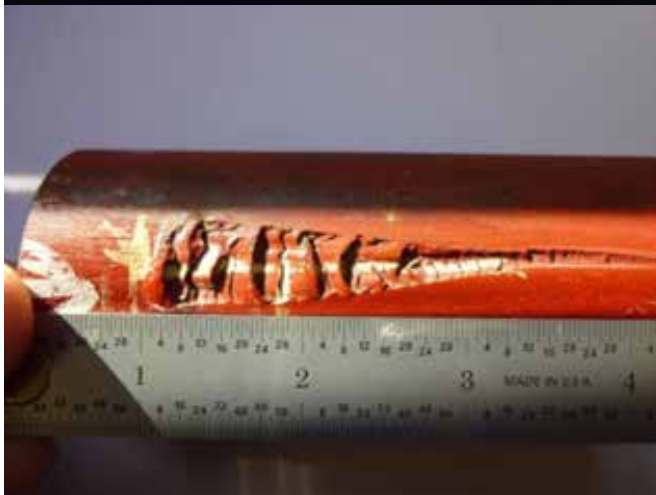
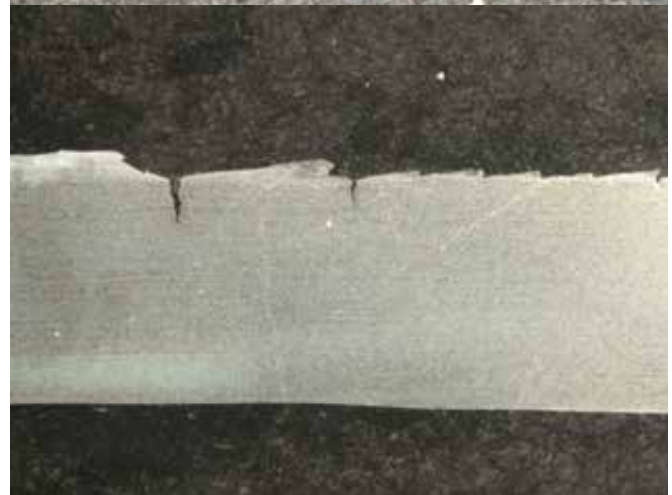
**Plow Marks:** Note the increase in hardness and fractures emanating from the root of the mechanical damage. Immediate repair is critical to reduce the amount of cracking at the root of this damage followed by non destructive examination such as Magnetic Particle or Liquid Penetrant Inspection to assure complete removal of the cracking.

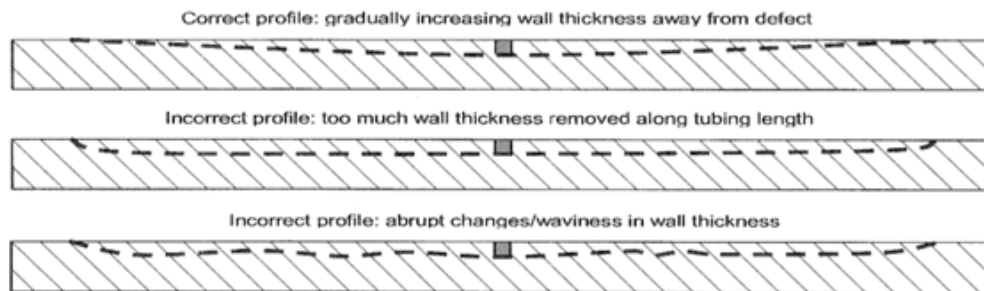
Figure 3: Tube profile examples after defect removal. Take note that the gradual profile change is preferred as seen in the top illustration. While the bottom two illustrations show undesirable profiles with abrupt changes and transitions in wall thickness.

f. Figure 3 illustrates the proper and improper profiles of the final surface after repair.
