A Historical Perspective on Drum Crush and Some Basic Tips to Help Prevent It

A historical review and tips on the installation of wireline cable and what to look for to prevent drum crush and other field-related problems:

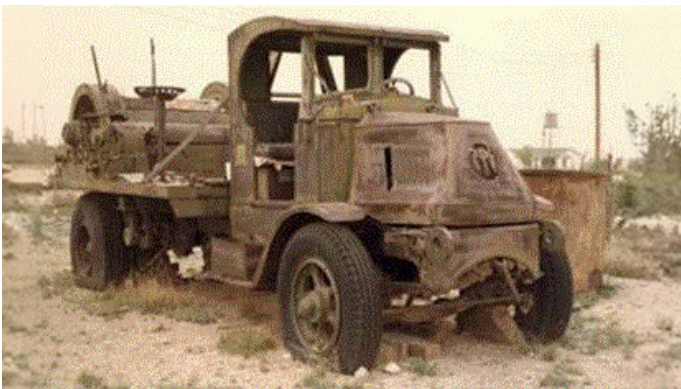
When logging the first “very” deep wells (18,000-20,000 feet) in West Texas, several electrical failures in US Steel cables were labeled factory defects. They discovered that all the failures had occurred at a point in the cable that had not been off the drum. In fact, the shorts were several layers down from any point on the cable that had been in the hole. It was the birth of what is now called “drum crush.” A test solution was to initially spool a new cable back and forth between two trucks, building up the spooling tension 500 pounds at a time until establishing a tension equal to the tension in the field. This test worked and unveiled the first understanding of “drum crush.”

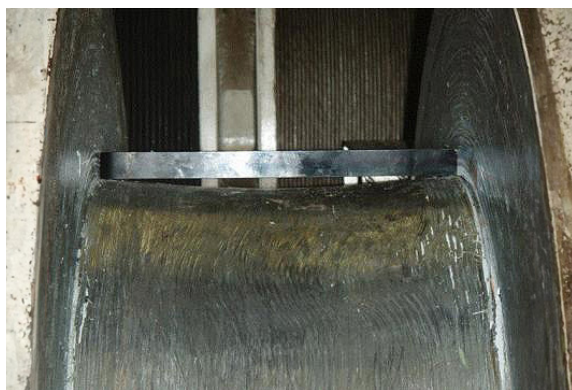
- Place a straight edge across the drum core, as shown in the picture below. There should be no visible gaps, indicating dips in core diameter. These dips may cause the cable to drop into the valley and lead to gaps in the spool job, causing changes in tension and, ultimately, field problems that may cause drum crush.
