Case Study 4

- Pad experienced sanding issues
- Sand control design was 'assumed' from prior pads
- Retrofit recompletions completed

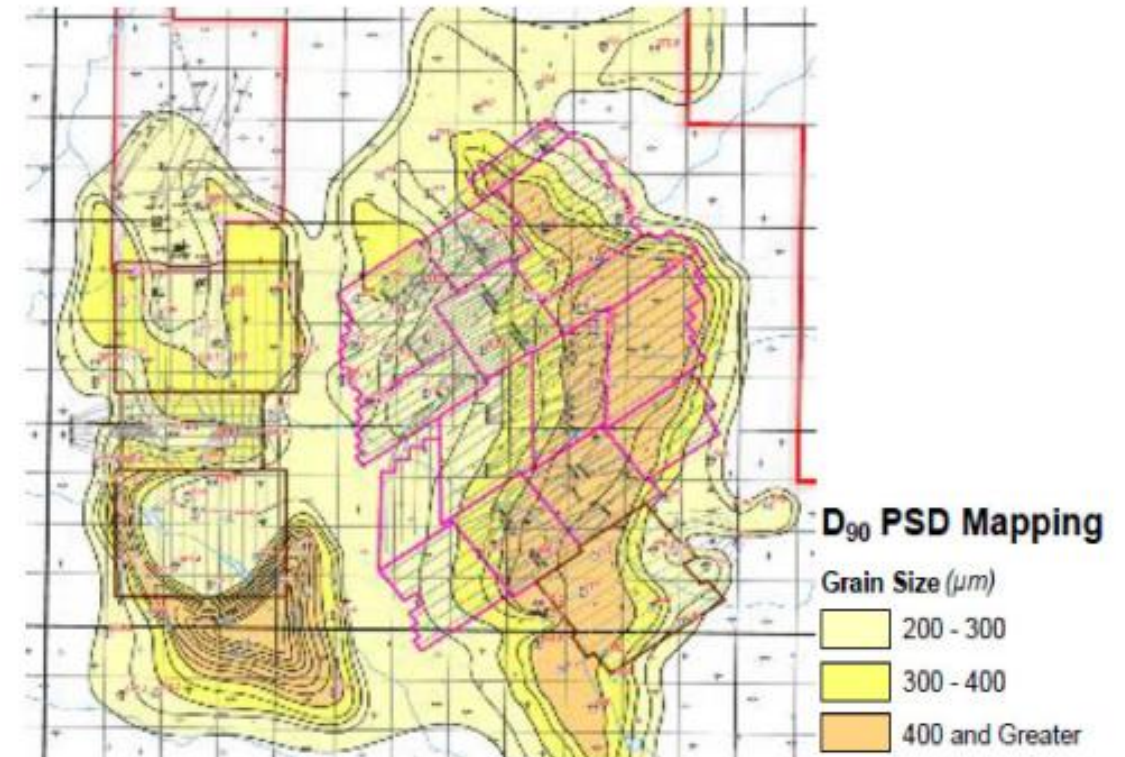
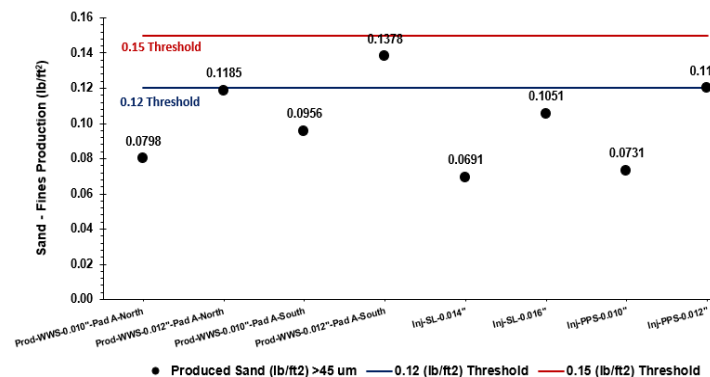
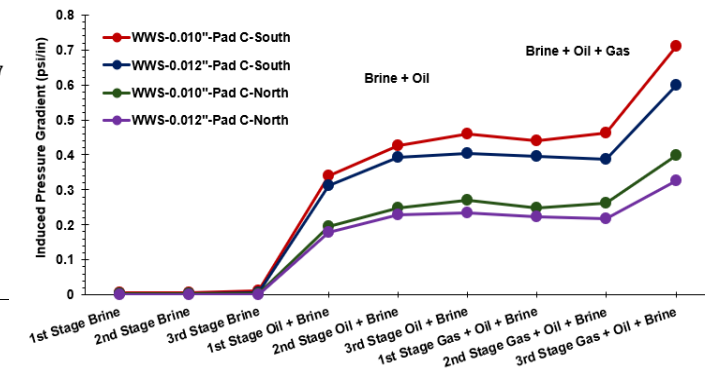
- Review sand control design cycle
- Conducted sand retention testing (SRT) and shape analysis to determine optimal sand control media
